Asbestos Survey Report

Colney Heath Parish Council Scout Hut

**Roestock Park
Admirals Close
Colney Heath
AL4 0QD**

Report reference: CE-4476-0282-1

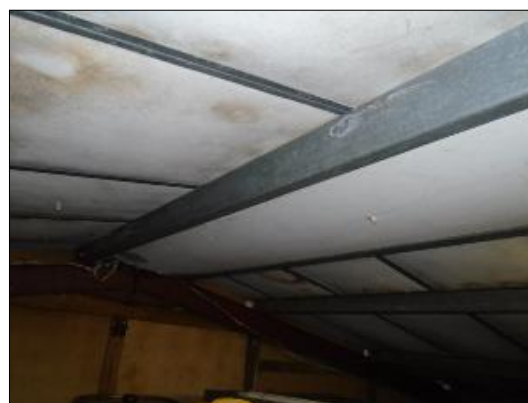
Accessibility:	Low
Condition:	Fair condition
Surface:	Fully sealed
Position:	Internal
Exposure:	No longer collected
Friability:	No longer collected
Amount:	> 10 m ² <= 50 m ²
RISK:	LOW (5)

Asbestos paper lining to fibreboard ceiling panels.

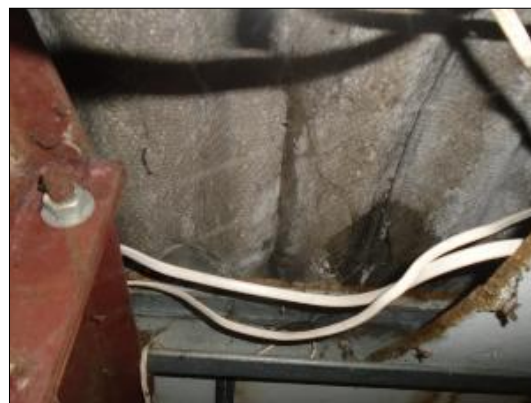
Accessibility:	Low
Condition:	Fair condition
Surface:	No seal
Position:	Internal
Exposure:	No longer collected
Friability:	No longer collected
Amount:	> 10 m ² <= 50 m ²
RISK:	MINOR (4)

Asbestos cement corrugated sheets forming roof

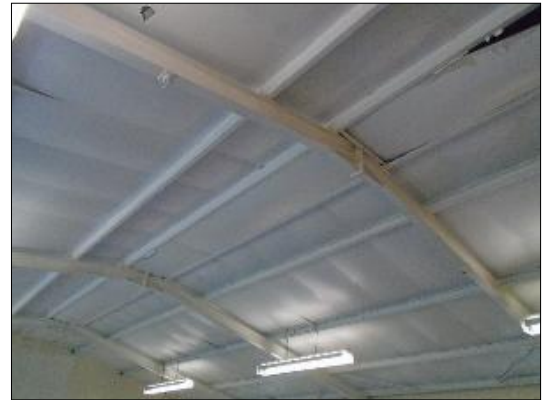
Accessibility:	Low
Condition:	Fair condition
Surface:	Fully sealed
Position:	Internal
Exposure:	No longer collected
Friability:	No longer collected
Amount:	> 10 m ² <= 50 m ²
RISK:	LOW (5)

Presumed asbestos paper lining to fibreboard ceiling panels

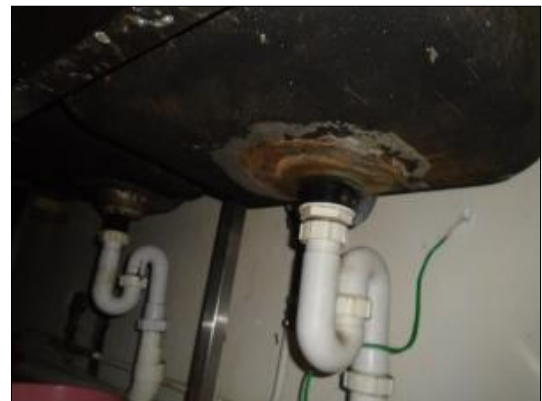
Accessibility:	Low
Condition:	Fair condition
Surface:	Fully sealed
Position:	Internal
Exposure:	No longer collected
Friability:	No longer collected
Amount:	> 10 m ² <= 50 m ²
RISK:	NONE

Non asbestos bitumastic coating to underside of sinks (No x 2)

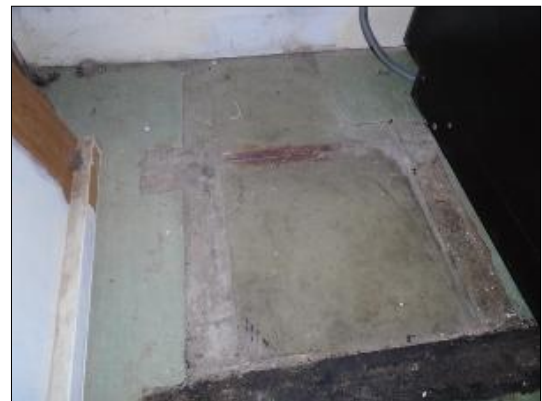
Accessibility:	Low
Condition:	Fair condition
Surface:	Fully sealed
Position:	Internal
Exposure:	No longer collected
Friability:	No longer collected
Amount:	<= 10 m ²
RISK:	MINOR (3)

Asbestos floor tiles (green) and bitumen adhesive beneath vinyl flooring

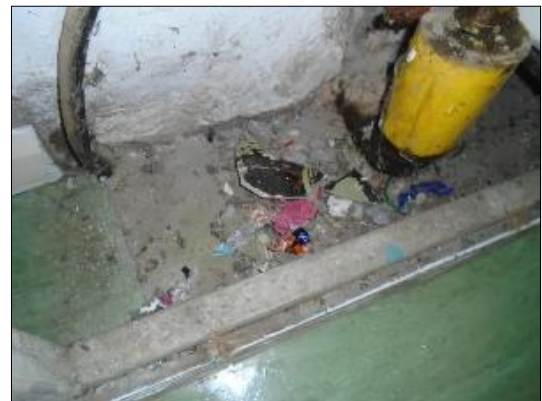
Risk Analysis	
Accessibility:	Low
Condition:	Fair condition
Surface:	Fully sealed
Position:	Internal
Exposure:	No longer collected
Friability:	No longer collected
Amount:	> 50 m ²
RISK:	MINOR (3)

Presumed asbetos floor tiles (green) and bitumen adhesive / associated debris beneath vinyl flooring

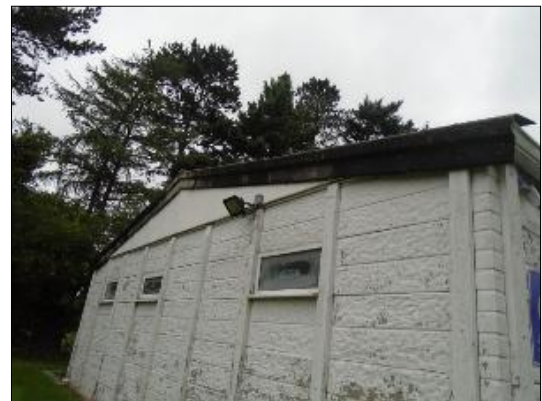
Accessibility:	Low
Condition:	Fair condition
Surface:	No seal
Position:	External
Exposure:	No longer collected
Friability:	No longer collected
Amount:	<= 10 m linear
RISK:	MINOR (4)

Asbestos cement ridge tiles to roof

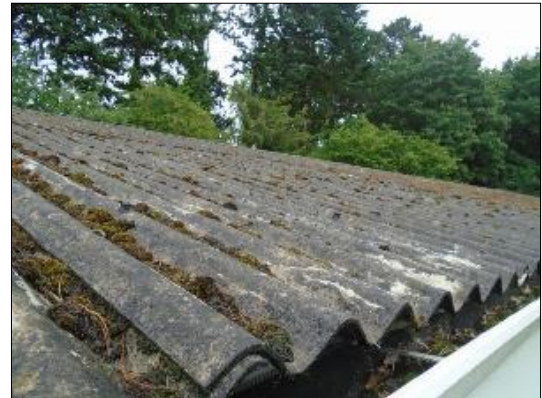
Accessibility:	Low
Condition:	Fair condition
Surface:	No seal
Position:	External
Exposure:	No longer collected
Friability:	No longer collected
Amount:	> 10 m ² <= 50 m ²
RISK:	MINOR (4)

Asbestos cement corrugated sheets forming roof

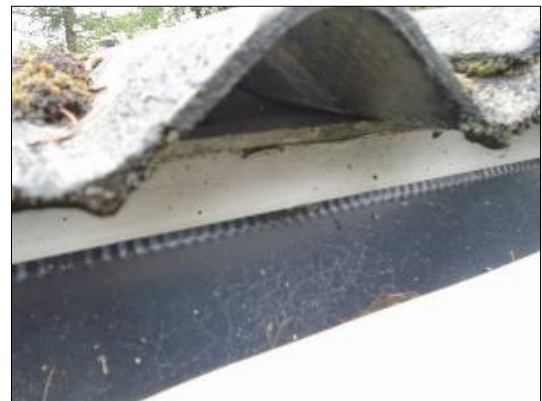
Accessibility:	Low
Condition:	Fair condition
Surface:	No seal
Position:	External
Exposure:	No longer collected
Friability:	No longer collected
Amount:	<= 10 m linear
RISK:	MINOR (4)

Asbestos cement panels beneath corrugated sheets to roof

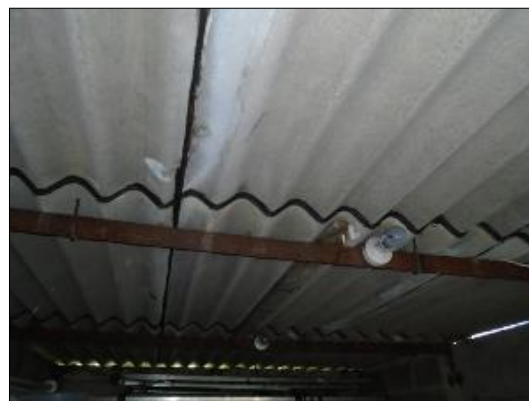
Accessibility:	Low
Condition:	Fair condition
Surface:	No seal
Position:	Internal
Exposure:	No longer collected
Friability:	No longer collected
Amount:	> 50 m ²
RISK:	LOW (6)

Asbestos cement corrugated sheets forming roof
