# ROESTOCK PARK HUT WORKING PARTY

## SCOUT FACILITIES REPORT ON SITE VISITS

| date | version | | Prepared by |
| 28 Dec 2023 | 1 | Issue for information | John Clemow |

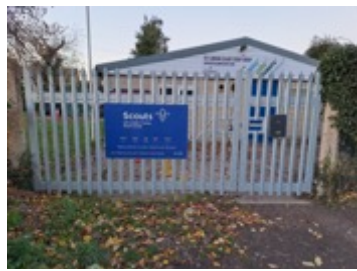
Gated entrance view

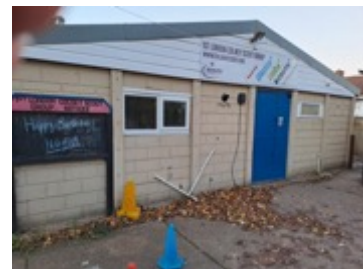
View of the front door

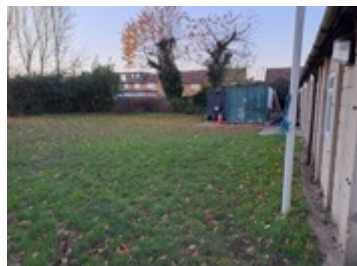
Garden view with outbuilding container

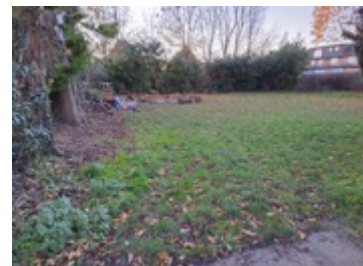
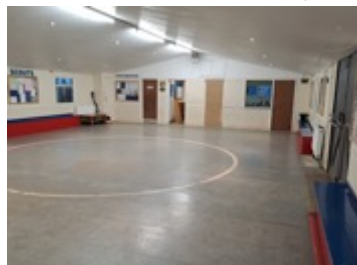
Hall views

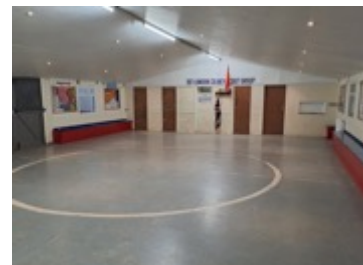
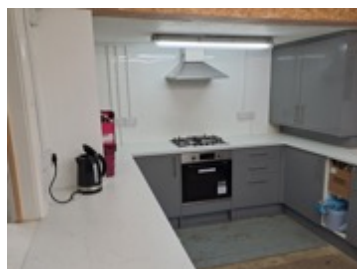
Kitchen

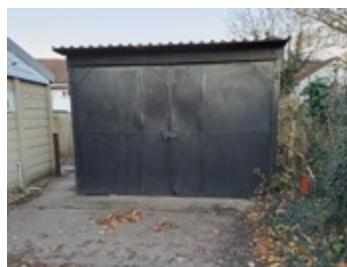
Lock up garage storage

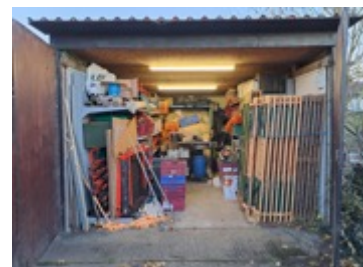
Lock up garage storage

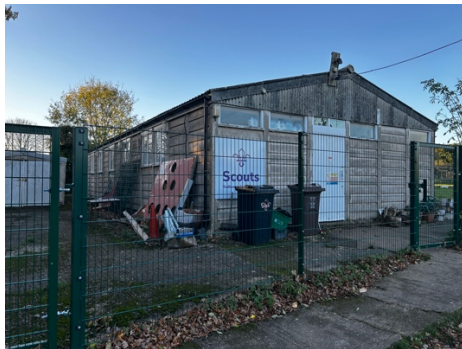
View of the Scout hut with new fencing

- 4.2 The fencing, recently installed is high quality, project cost around £12,500+VAT funded by a grant.
- 4.3 Internally the floor is formed of suspended timber joists with sheet vinyl on plywood or similar.
- 4.4 The entrance lobby provides access to the kitchen on one side and two WC's on the other. A slight ramp leads to the main hall space which has two store rooms at the far end. The ceiling is lined with painted fibreboard, ceiling insulation no known.
- 4.5 The two outbuildings are of similar construction on (presumed) concrete bases. The grounds are generally grassed, edged with trees on three boundaries.

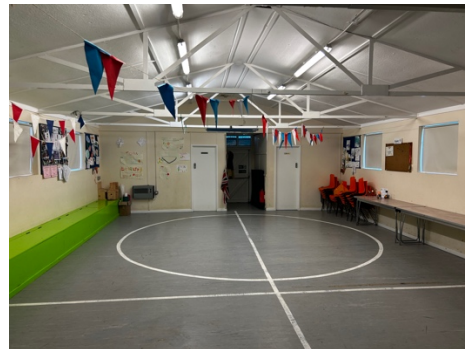
Interior of the hall with store rooms at the far end.

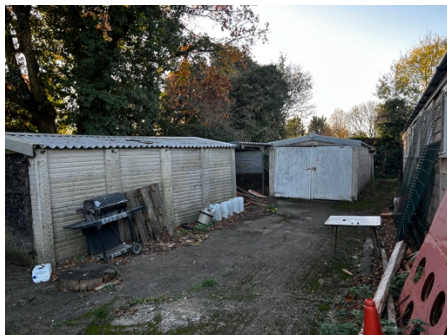
Building on the right is for secure storage

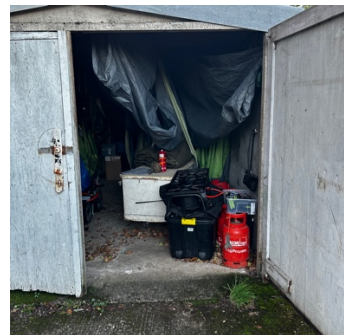
Gas bottles are planned to be caged

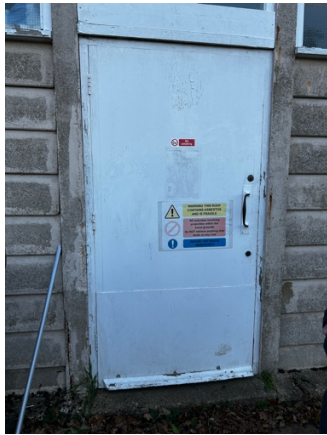
- 6.1 The Scout hut appears to be structurally sound but the windows and front door are dilapidated. The asbestos cement roof covering may need to be replaced, porosity is being monitored.

Front door with warning signs regarding asbestos

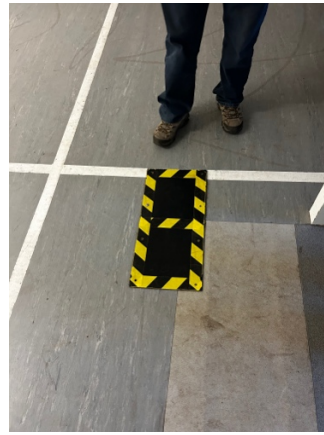
Do not step patch on hall floor

- 6.2 A small section of the hall floor collapsed and is marked to avoid stepping. Deterioration of the floor joists has been noted, possibly due to water damage, and may need to be replaced. The sheet vinyl flooring finish is aged but in fair condition. Some of the fibreboard ceiling panels show signs of dislodged fixings.
- 6.3 The ramped section in the entrance lobby is “spongy” underfoot and is planned to be replaced.
- 6.4 The kitchen appears to be in reasonable condition and the sheet vinyl flooring is relatively new. The WCs spaces are functional but spartan (WC facility has grab rails but access is not DDA compliant)

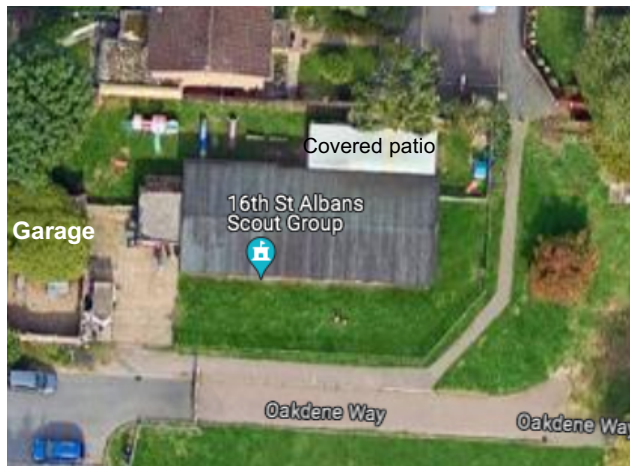
Garage roof covered in climber.

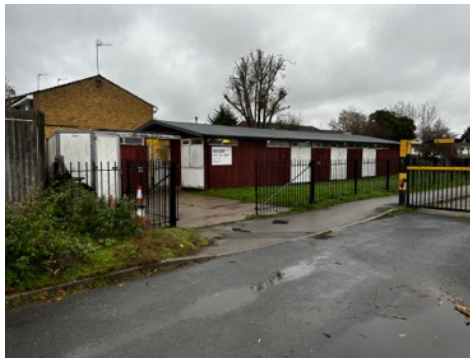
View of the Scout hut

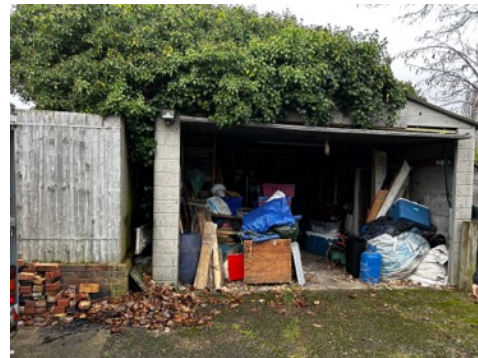
Garage used for storage

6.6 The asbestos cement roof to the garage is not being ACM managed.

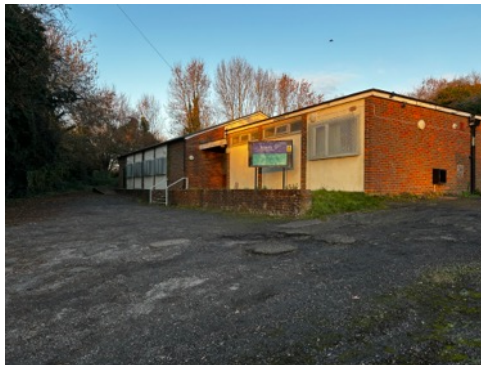
View from the entrance

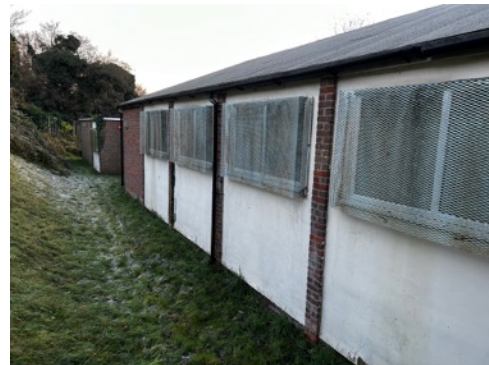
The outdoor space slopes steeply.

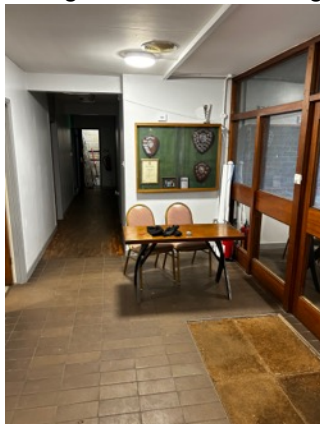
Entrance lobby with quarry tile floor

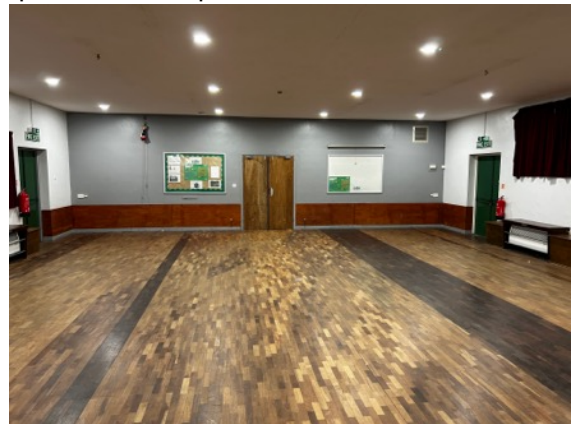
Main hall with high quality wooden strip flooring.

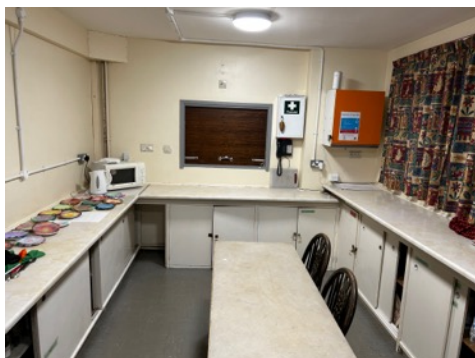
Kitchen fittings have not been modernized but is in reasonable condition

6.1 The building is a good quality facility but would benefit from modernization of the kitchen and WCs.

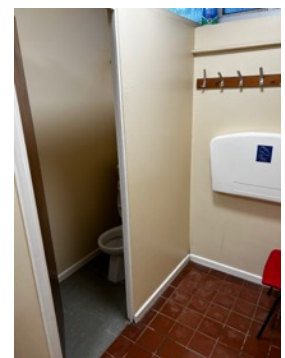
There is no disabled WC. The District Council provided for a ramped access as the hall is the local polling station.
