## ■ Commercial Building Survey

Scout Hut  
Roestock Park  
Admiral Close  
Colney Heath  
Hertfordshire  
AL4 0QD

Friday 10<sup>th</sup> February 2023

Prepared by:  
**Brasier Freeth LLP  
Wentworth Lodge  
Great North Road  
Welwyn Garden City  
Hertfordshire  
AL8 7SR**

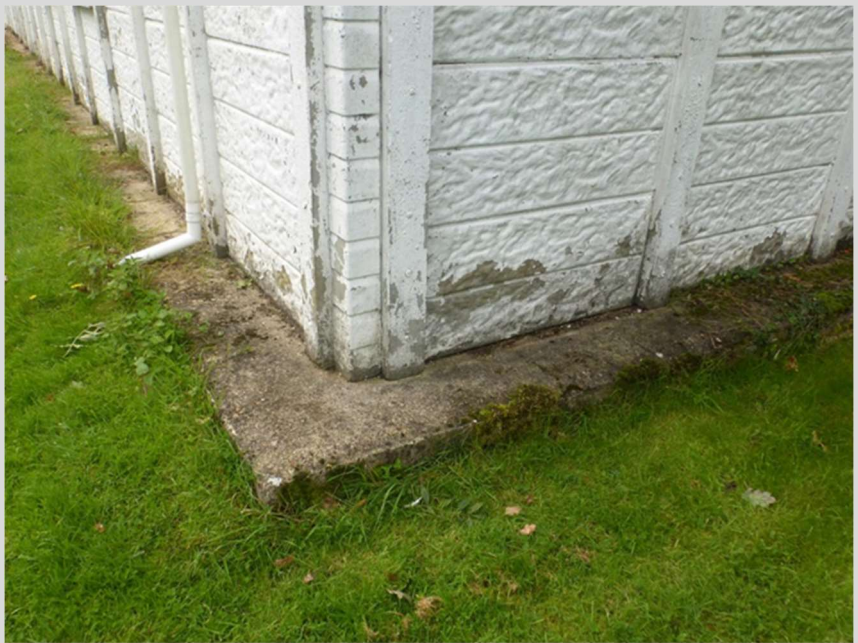
JPEG No: P1220863

**PHOTO 15.1.3:**

Prefabricated concrete post and panel walls formed on floor slab or raft foundation visible externally to perimeter.

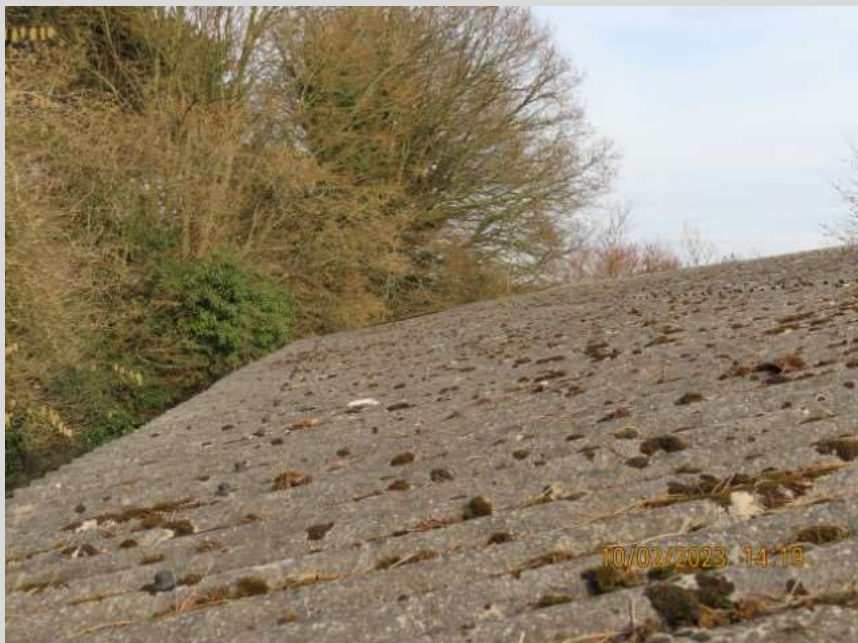
JPEG No: IMG\_9069

**PHOTO 16.2.1:**

View of rear roof slope with vegetation and moss growth to asbestos cement sheeting, vegetation also blocking rainwater gutters.

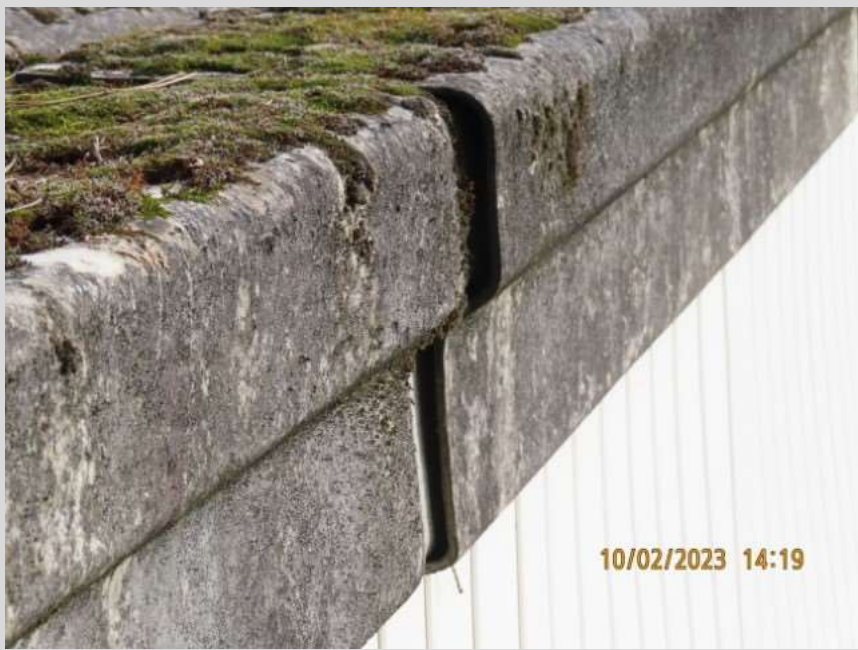
JPEG No: IMG\_9071

- 16.2.3 Since 2017 we believe the verges have been replaced as they appear to be in better condition, although in some areas the verges are slightly misaligned and displaced.

**PHOTO 16.2.3:**

Replacement verge cappings which are displaced at joints.

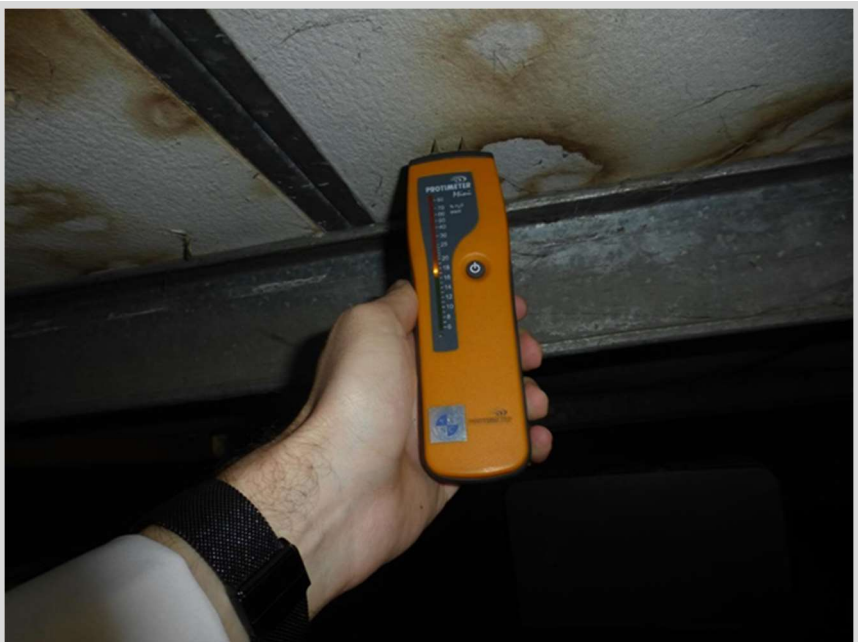
JPEG No: P1210834

**PHOTO 16.2.6:**

Stains evident to fibre boarding on underside of roof slopes and moisture detected in roof space.

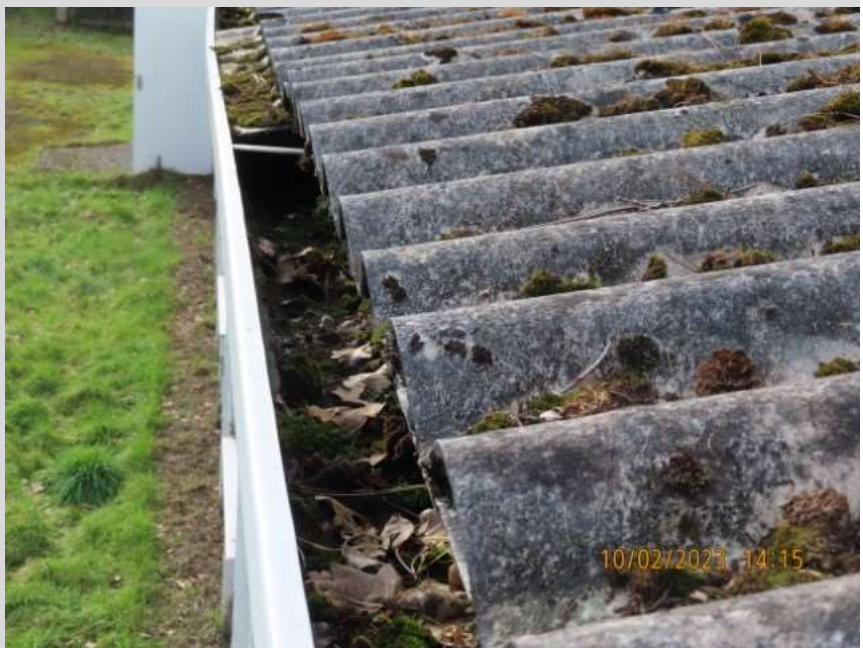
JPEG No: IMG\_9056

**PHOTO 17.2.2:**

Misaligned rear gutter.

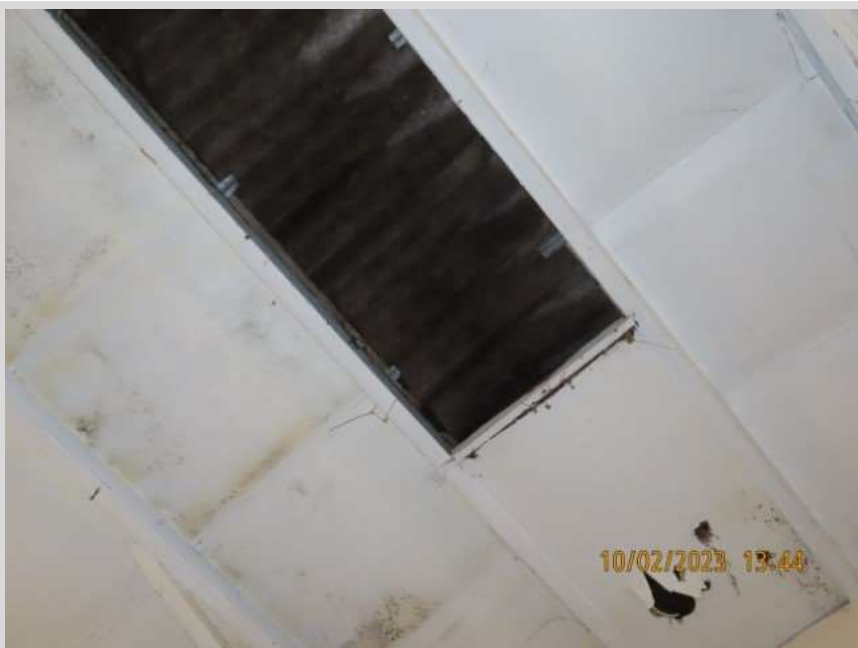
JPEG No: IMG\_9002

**PHOTO 21.2.1:**

Fibre board panel missing.

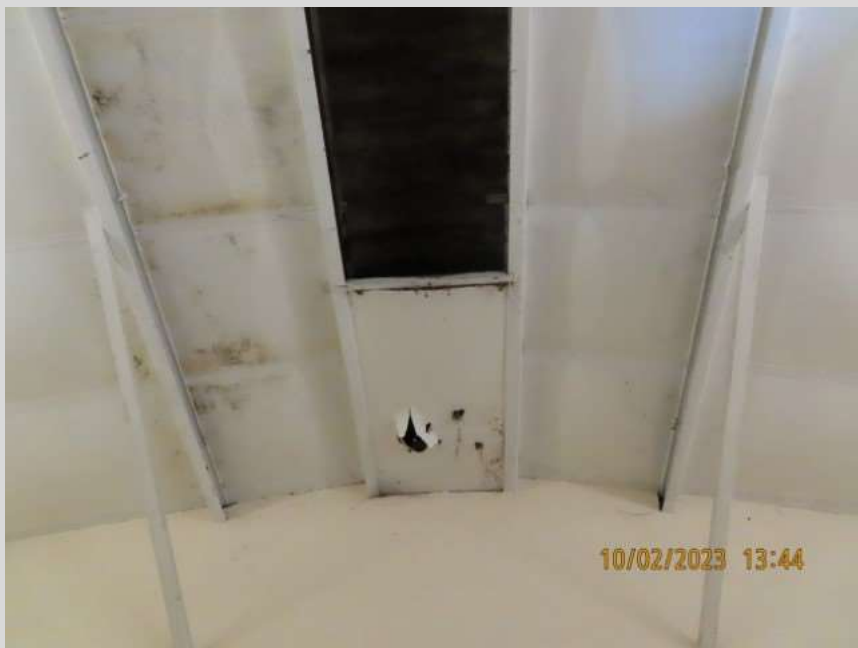
JPEG No: IMG\_9003

**PHOTO 21.2.1:**

Condensation damage  
on ceiling boards  
adjacent to missing  
panel.

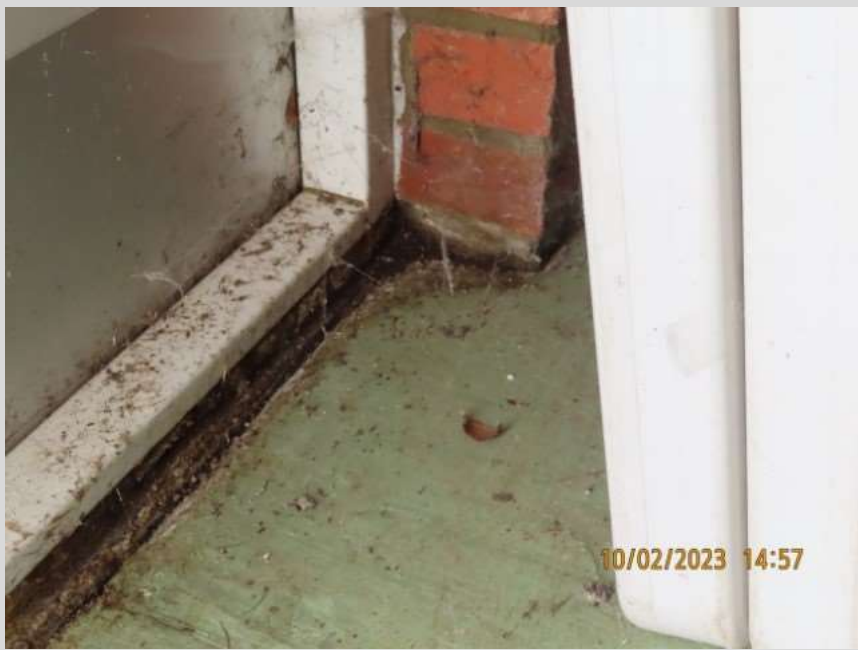
JPEG No: IMG\_9117

**PHOTO 22.2.7:**

Damp floor by entrance  
door threshold.

- 22.2.5 It is recommended that ventilation be introduced to the kitchen to remove moisture and prevent condensation and that timber skirtings in the areas where floors are cleaned with water are replaced with waterproof skirtings.
- 22.2.6 The walls generally appear to be stable, the cracks are likely to be explained by shrinkage movement in the blockwork masonry.
- 22.2.7 Generally, moisture meter readings revealed that the walls are essentially dry but, some dampness exists at the junction of the wall and floor interface near the entrance doors.

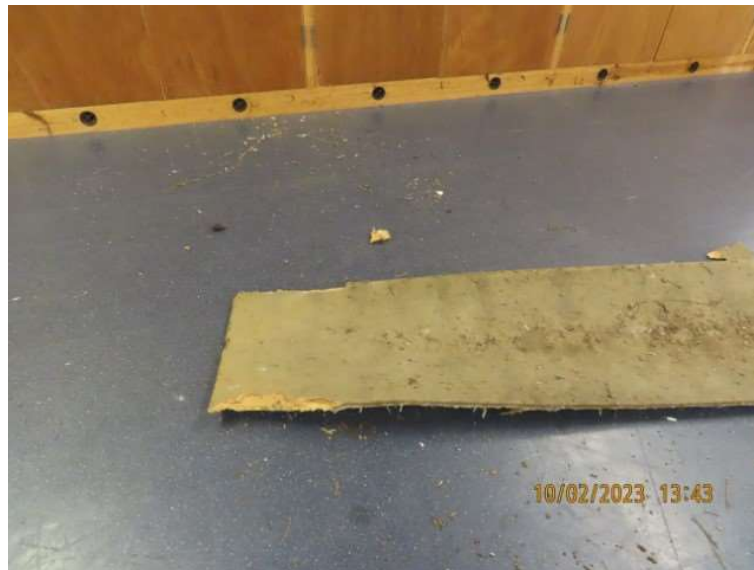
**JPEG No: IMG\_9000**

Ceiling panel fallen onto floor.

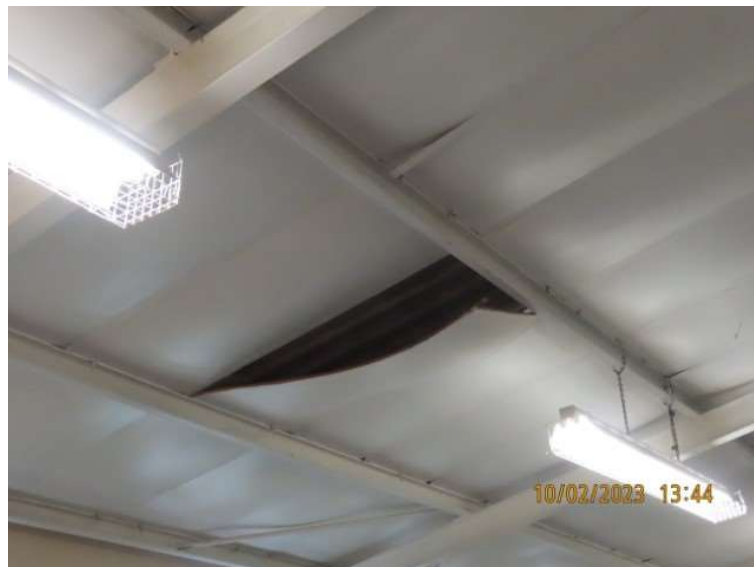
**JPEG No: IMG\_9001**

Bowing ceiling panel caused by condensation damage.

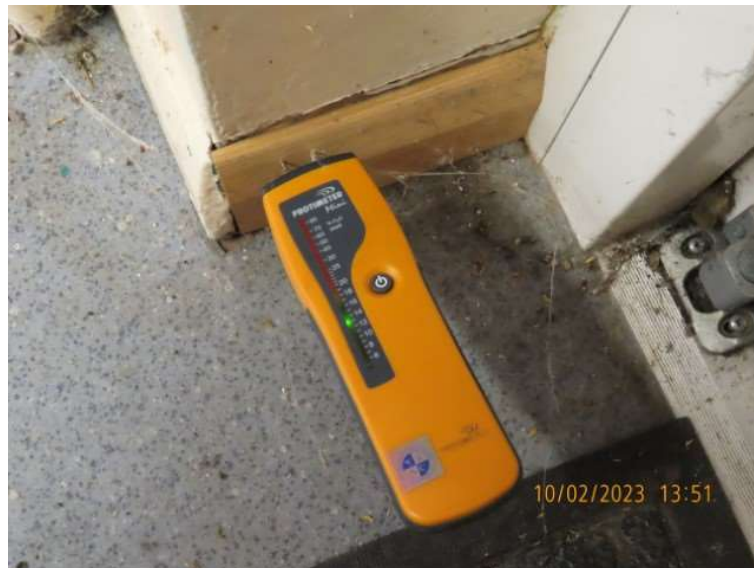
Replacement skirting near fire exit which is dry on moisture meter.

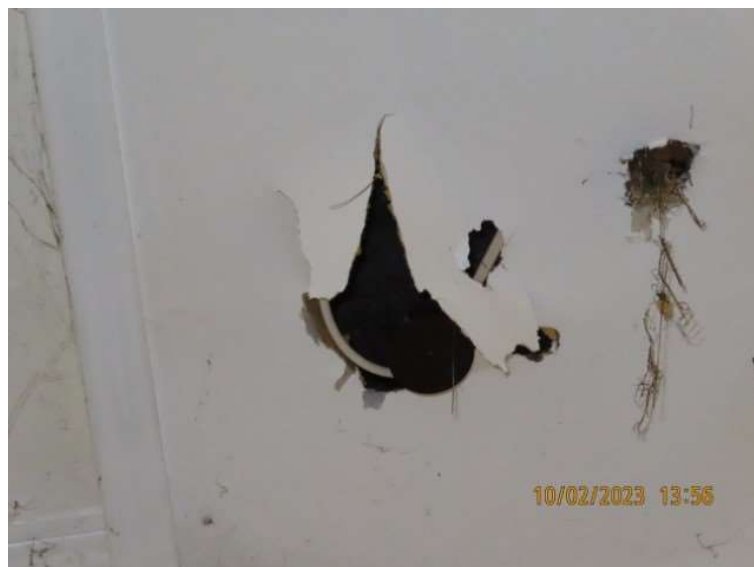
**JPEG No: IMG\_9008**

Damage to ridge panel, presumably caused by routing of cable above.

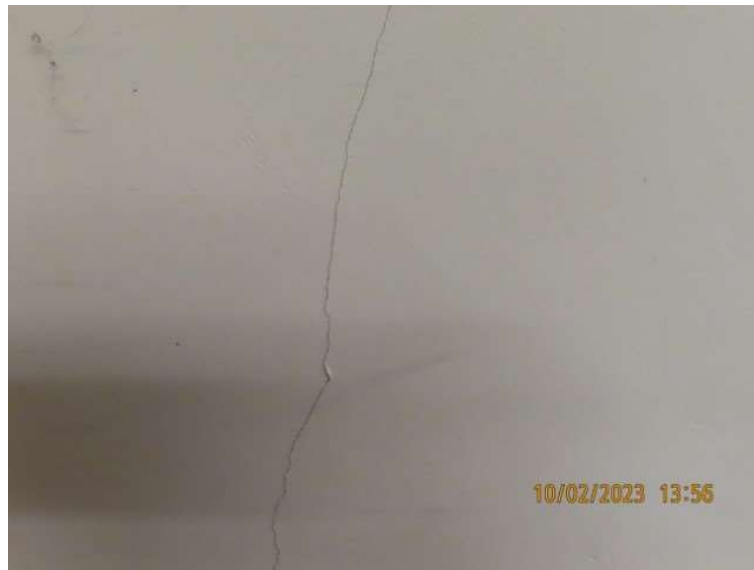
**JPEG No: IMG\_9012**

Typical shrinkage cracking in plaster wall to hall.

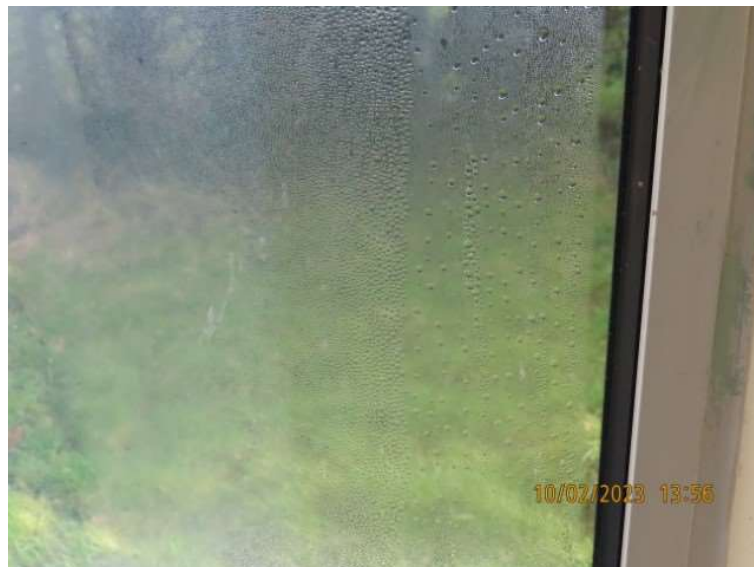
**JPEG No: IMG\_9013**

Interstitial condensation on perspex glazing.

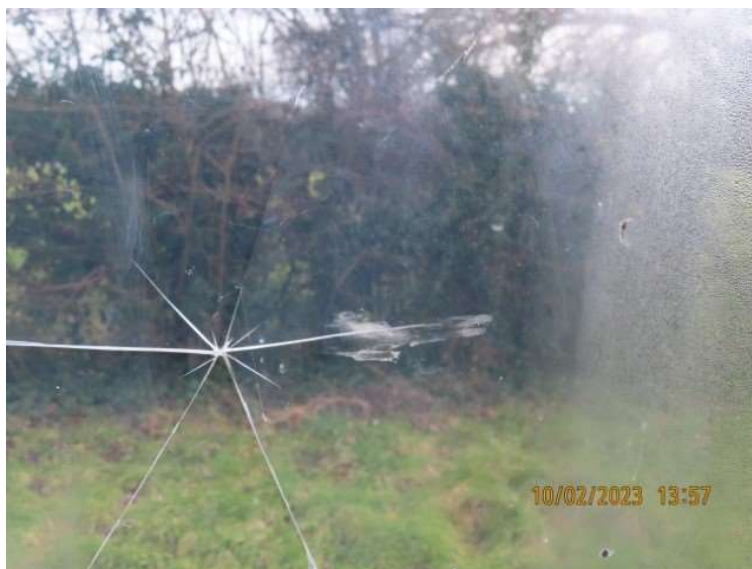
**JPEG No: IMG\_9015**

Impact damage on perspex glazing.

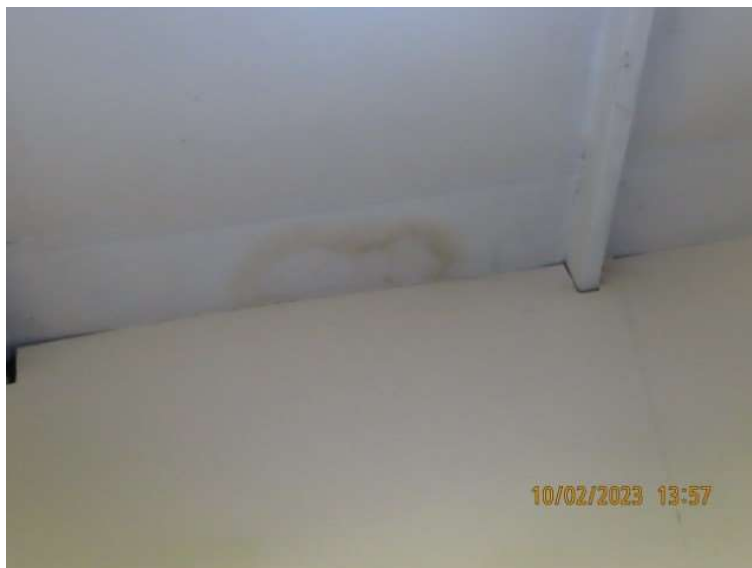
**JPEG No: IMG\_9017**

Typical water damage on hall roof.

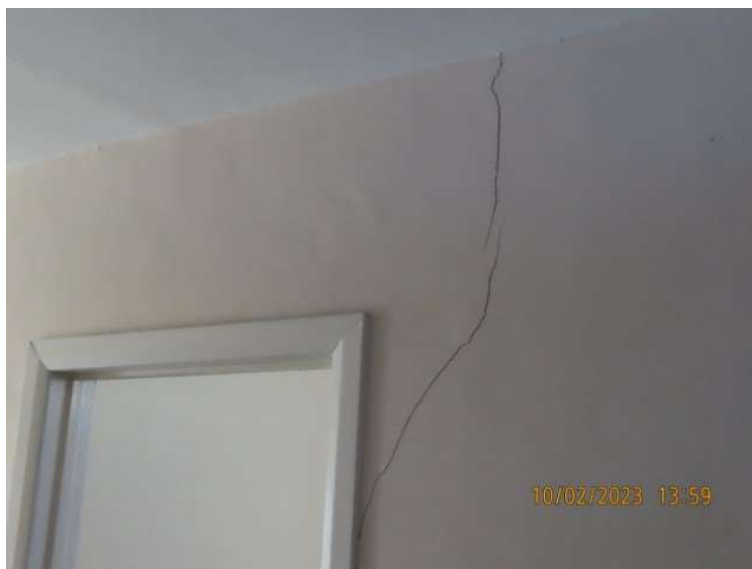
**JPEG No: IMG\_9018**

Shrinkage cracking in plaster which requires decorative repair.

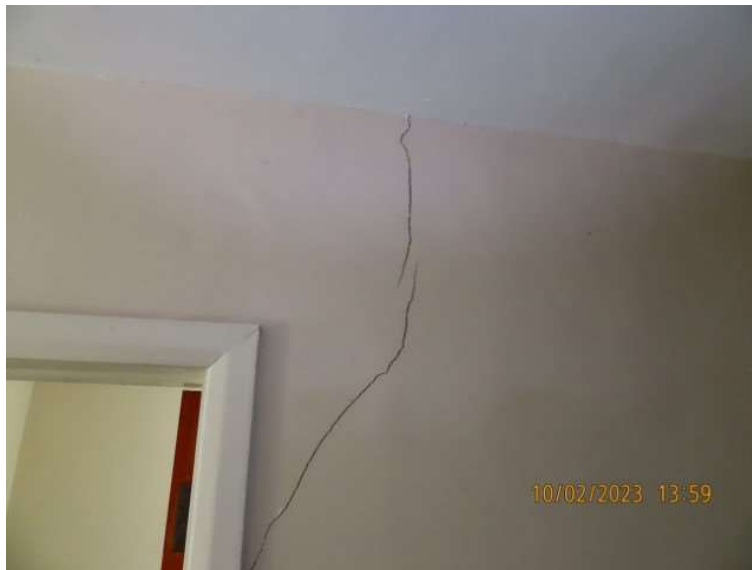
**JPEG No: IMG\_9021**

Shrinkage cracking in plaster which requires decorative repair.

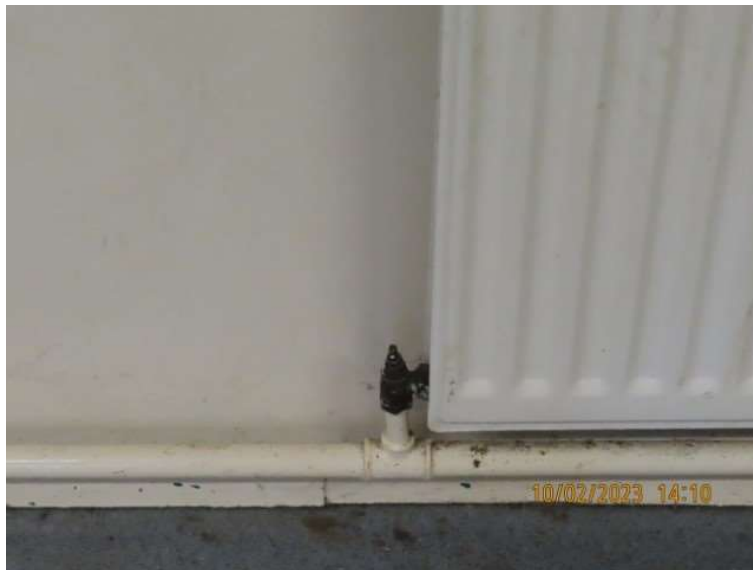
**JPEG No: IMG\_9040**

Lockshield valve cap missing to radiator – typical example.

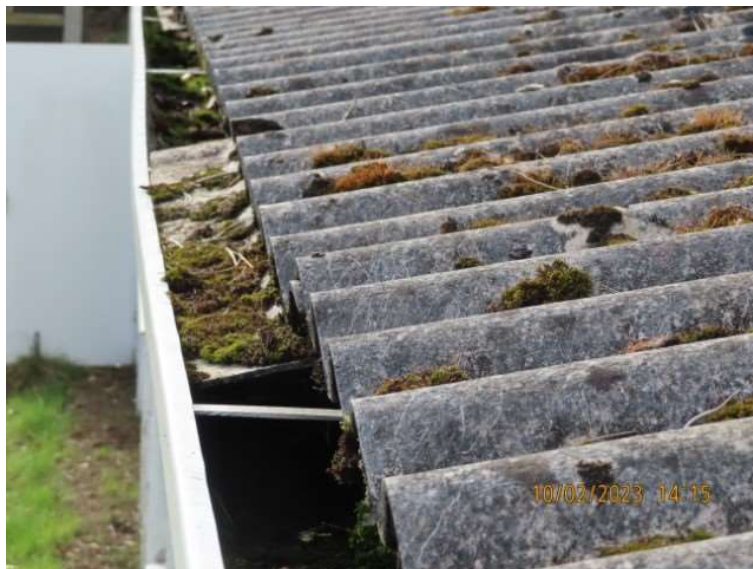
**JPEG No: IMG\_9045**

Bowing gutter and debris in gutter and moss growth on roof.

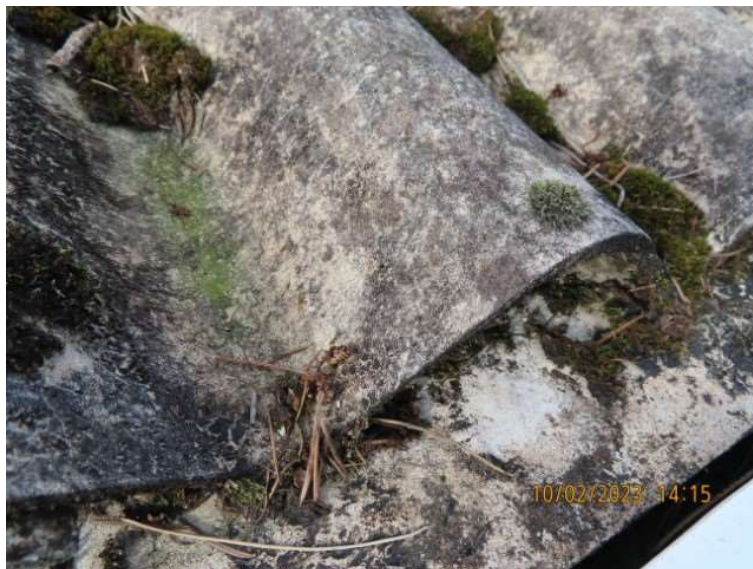
**JPEG No: IMG\_9052**

Surface degradation on asbestos cement sheeting showing signs of aging.

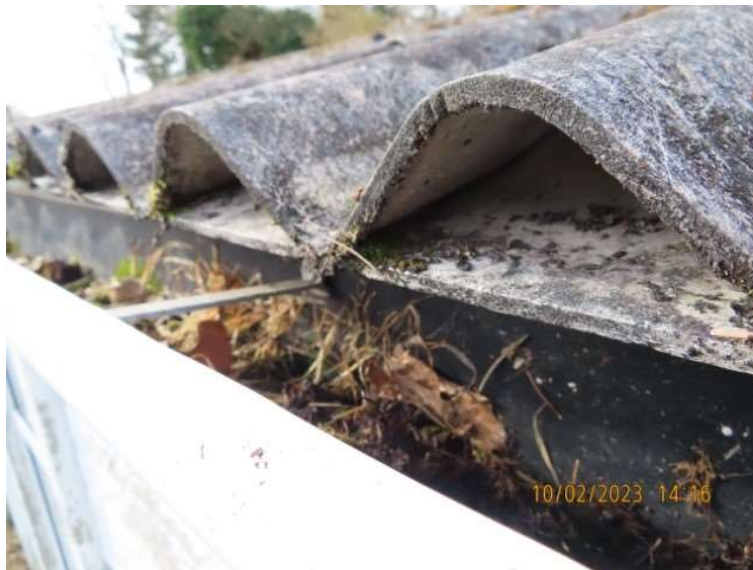
**JPEG No: IMG\_9057**

Filler pieces missing under corrugations to asbestos cement roof.

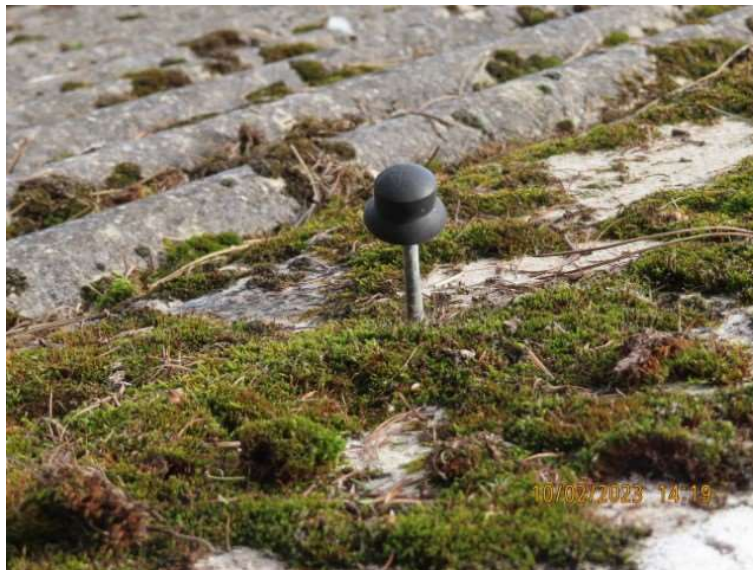
**JPEG No: IMG\_9067**

Loose fixing bolt to roof sheet.

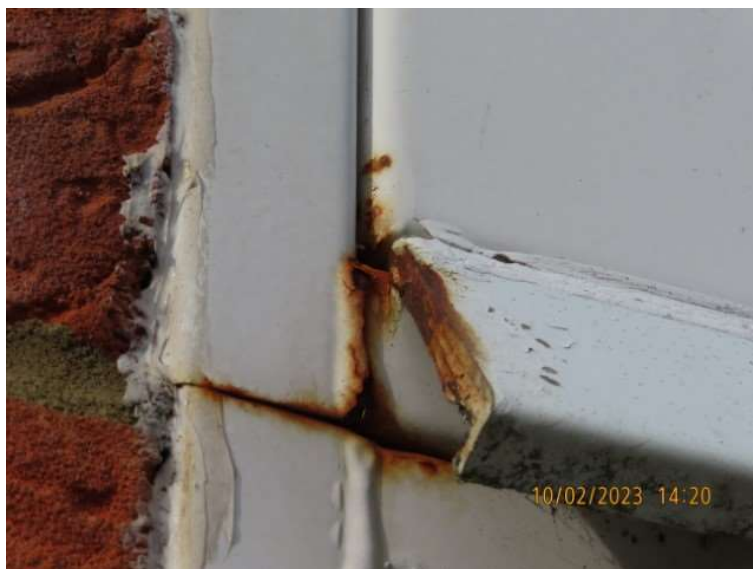
**JPEG No: IMG\_9072**

Displaced and corroded head trim to entrance door.

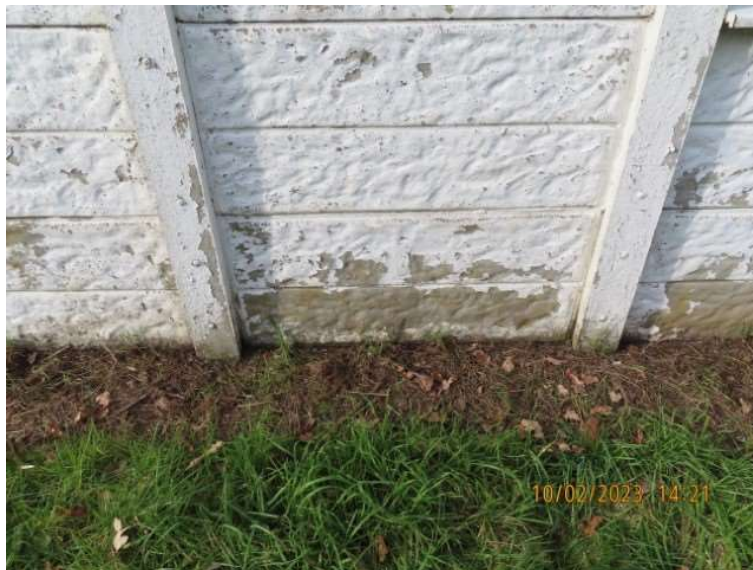
**JPEG No: IMG\_9073**

Flaking paintwork to front elevation.

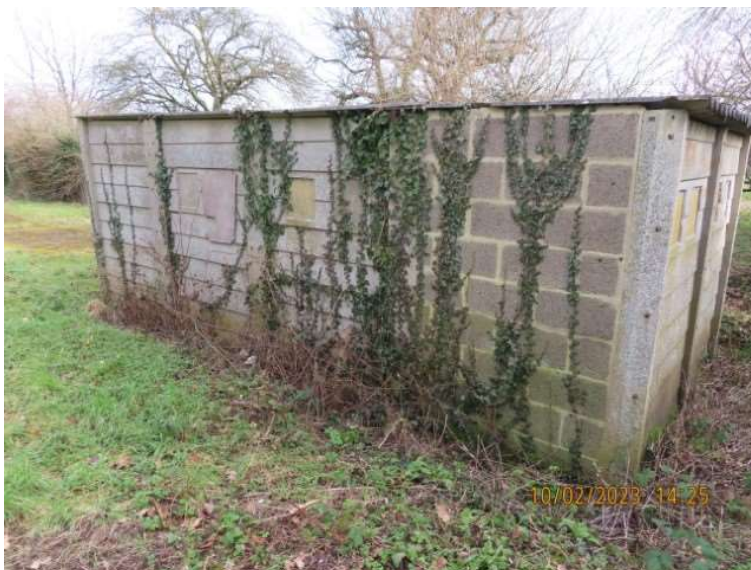
Overgrown vegetation to garage, displaced verge and broken sheets.

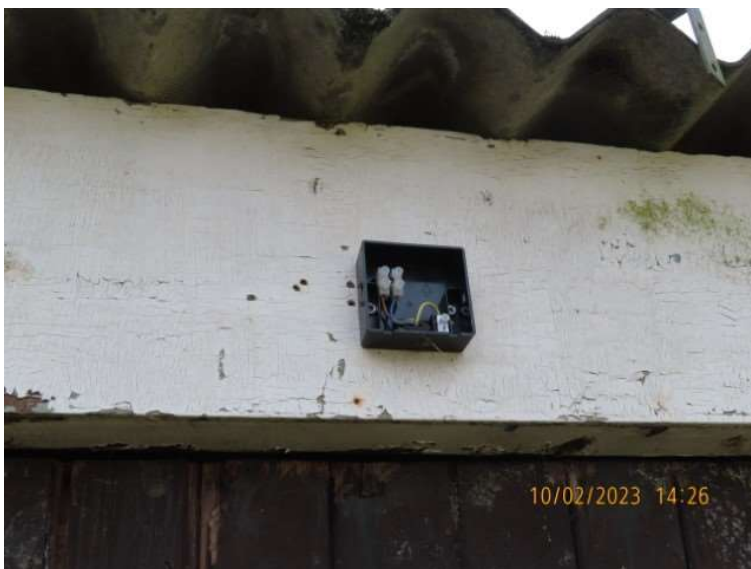
**JPEG No: IMG\_9099**

Exposed connector box with exposed wiring to garage.

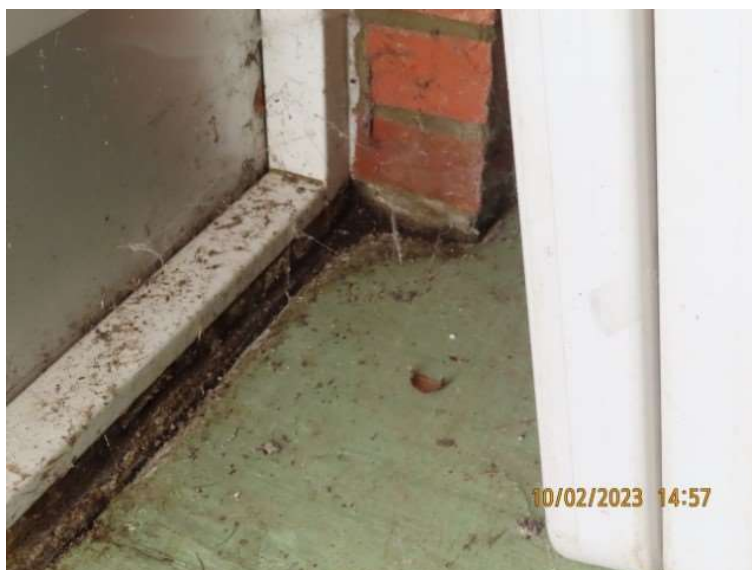
**JPEG No: IMG\_9116**

Damp flooring on entrance door threshold.
