# ROESTOCK PARK HUT WORKING PARTY

## SCOUT FACILITIES REPORT ON SITE VISITS

| date | version | | Prepared by |
| 28 Dec 2023 | 1 | Issue for information | John Clemow |

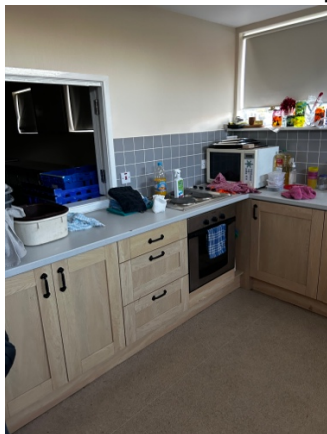
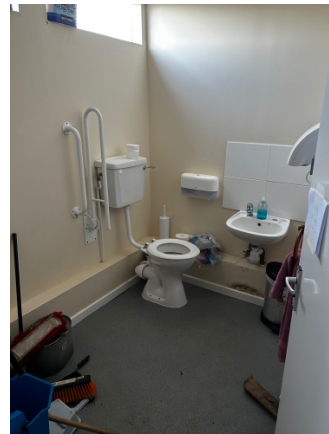
Do not step patch on hall floor

- 6.2 A small section of the hall floor collapsed and is marked to avoid stepping. Deterioration of the floor joists has been noted, possibly due to water damage, and may need to be replaced. The sheet vinyl flooring finish is aged but in fair condition. Some of the fibreboard ceiling panels show signs of dislodged fixings.
- 6.3 The ramped section in the entrance lobby is “spongy” underfoot and is planned to be replaced.
- 6.4 The kitchen appears to be in reasonable condition and the sheet vinyl flooring is relatively new. The WCs spaces are functional but spartan (WC facility has grab rails but access is not DDA compliant)

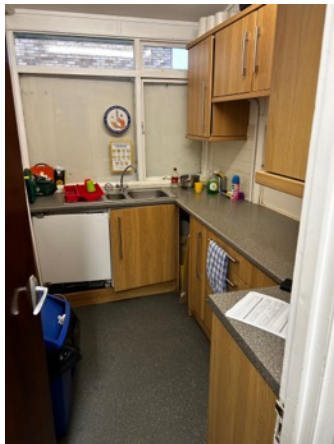
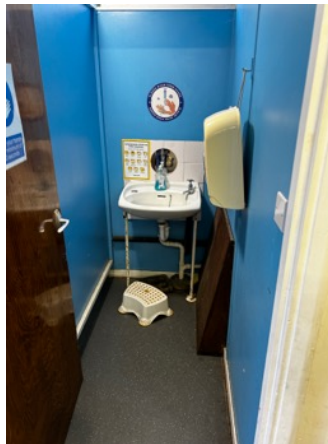
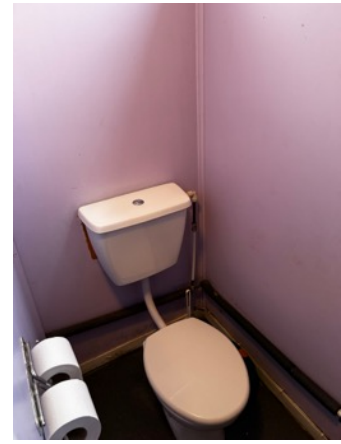
- 4.2 Internally the floor is vinyl finish on a screeded concrete base. The vinyl flooring was recently replaced.
- 4.3 The entrance lobby provides access to the kitchen, two WC's (no disabled facility), and a store room.
