## ■ Commercial Building Survey

Scout Hut  
Roestock Park  
Admiral Close  
Colney Heath  
Hertfordshire  
AL4 0QD

Friday 10<sup>th</sup> February 2023

Prepared by:  
**Brasier Freeth LLP  
Wentworth Lodge  
Great North Road  
Welwyn Garden City  
Hertfordshire  
AL8 7SR**

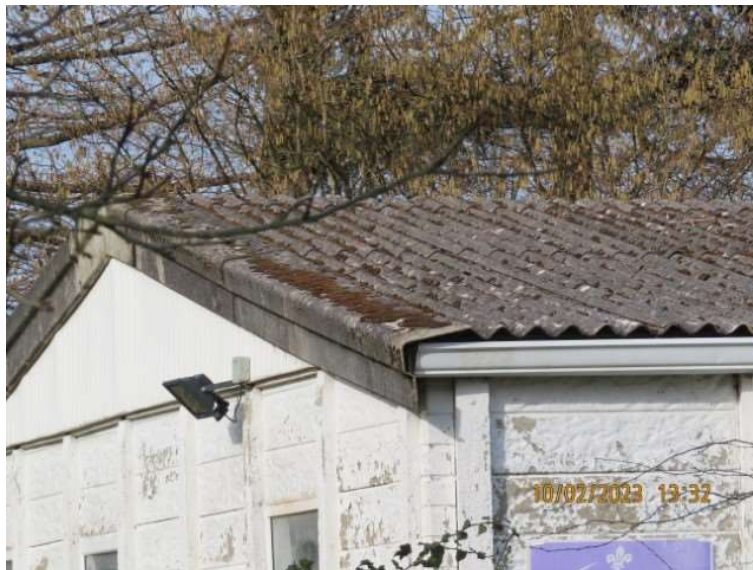
Displaced verge capping and moss on roof.

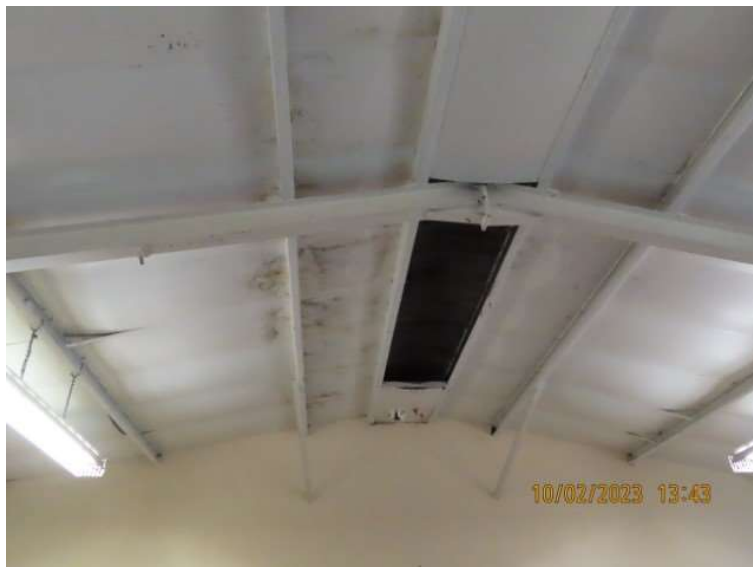
Water damaged ceiling boards through condensation staining and missing ceiling panel to ridge.

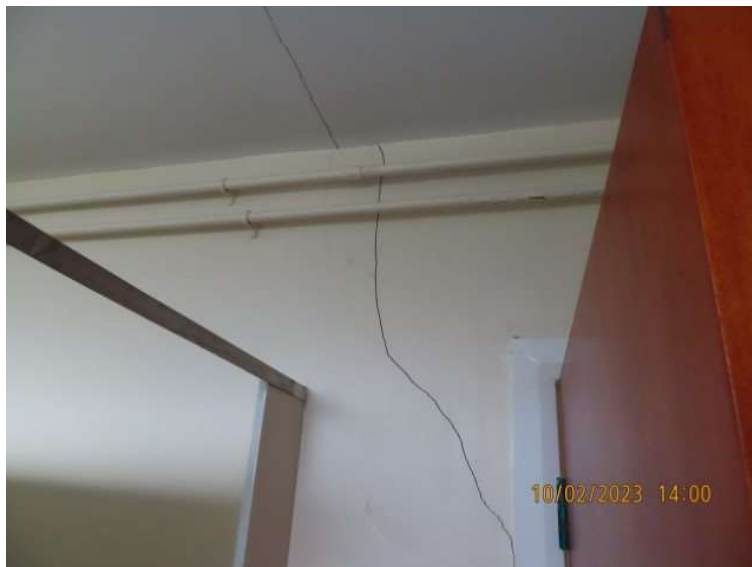
Shrinkage cracking in plaster which requires decorative repair.

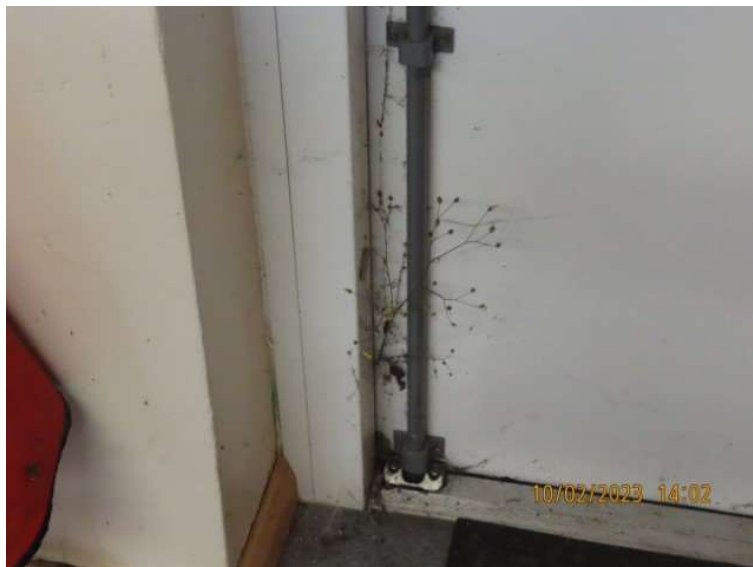
Vegetation growing through fire escape door. Note: corrosion on frame at junction with plaster.

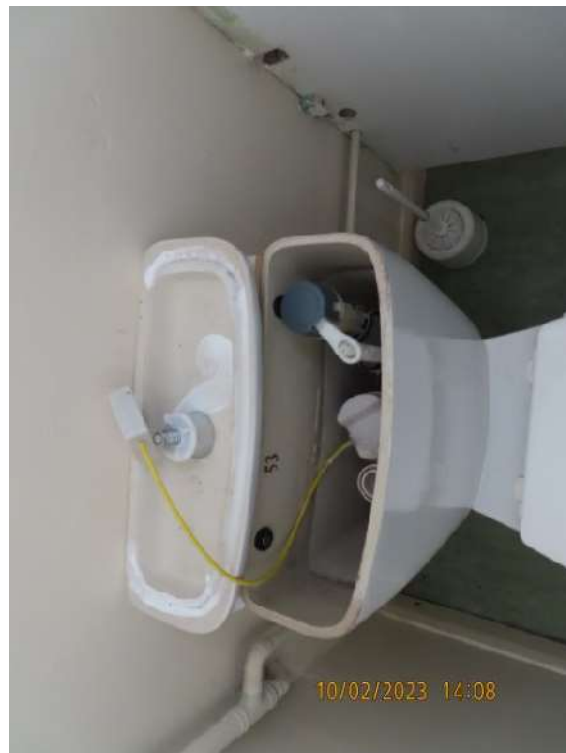
Broken flushing cistern to female WC.

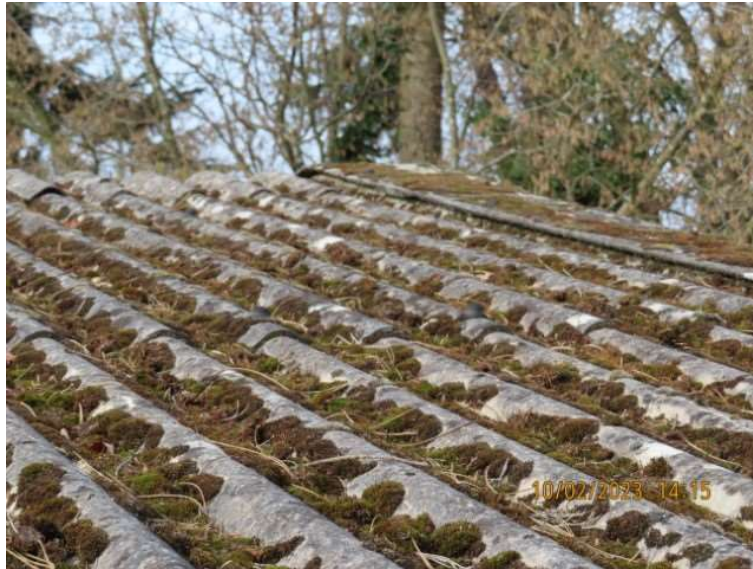
Moss growth on roof – typical example.

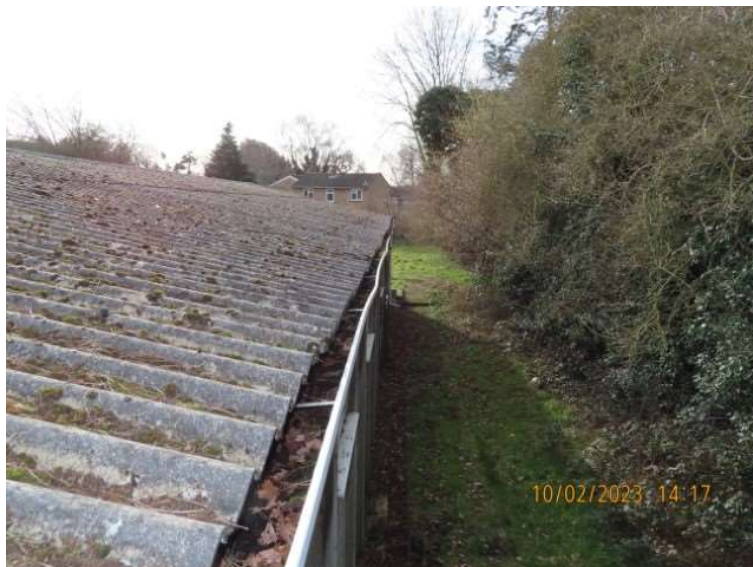
Irregular guttering to rear elevation.

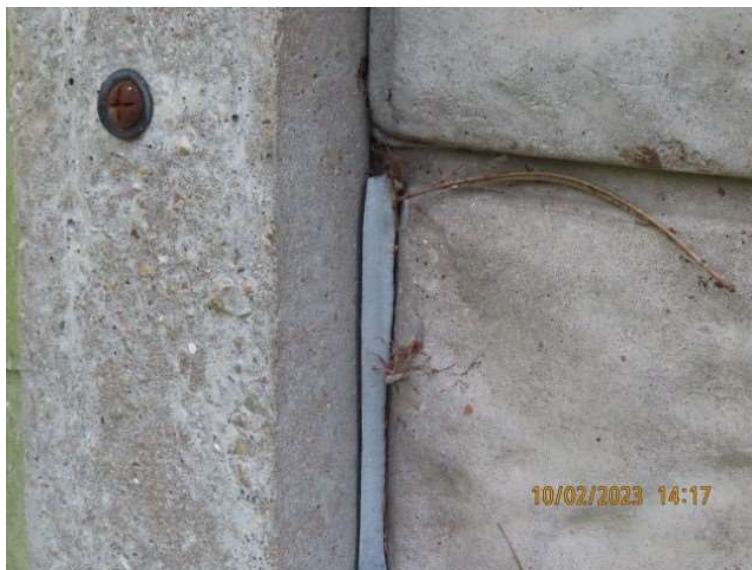
Mastic infill between panels and posts of concrete frame.

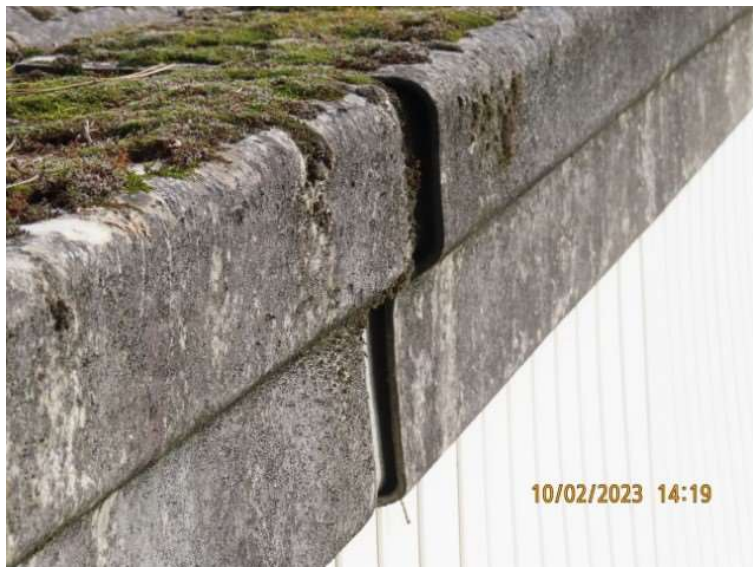
Open joint to verge capping.

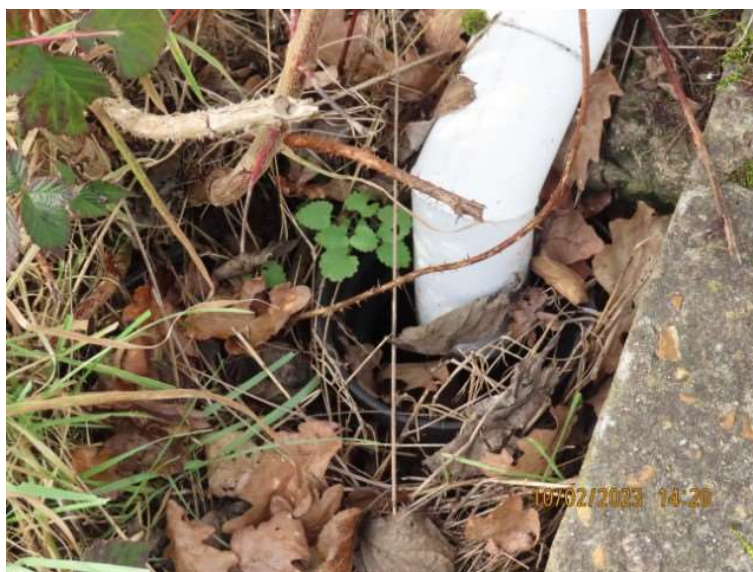
**JPEG No: IMG\_9072**

Un-sealed gulley connection to rainwater downpipe.

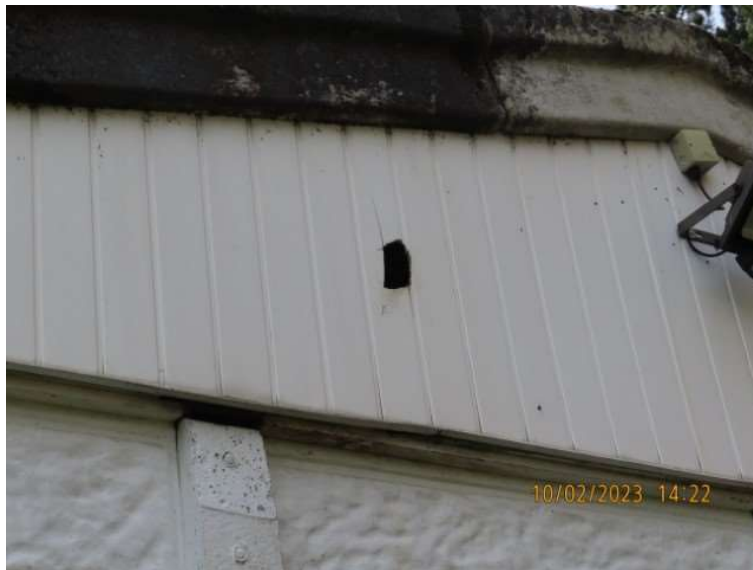
**JPEG No: IMG\_9081**

Hole in PVC weatherboarding to gable.

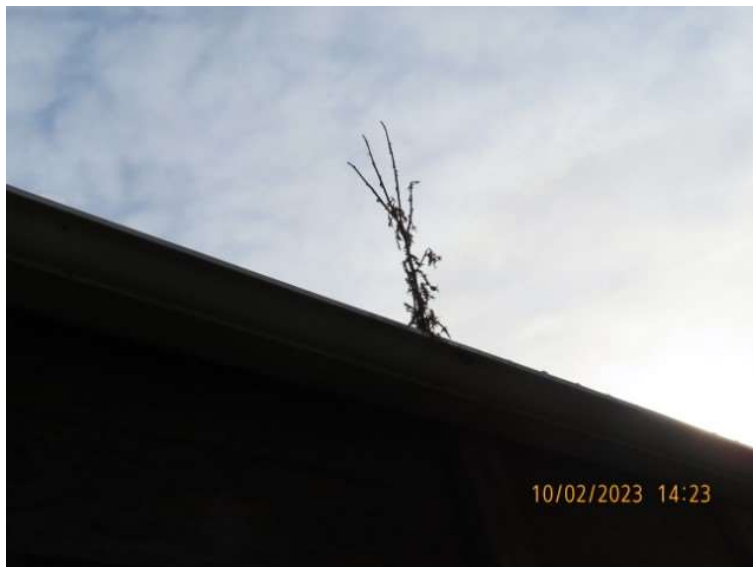
**JPEG No: IMG\_9088**

Vegetation in gutter.

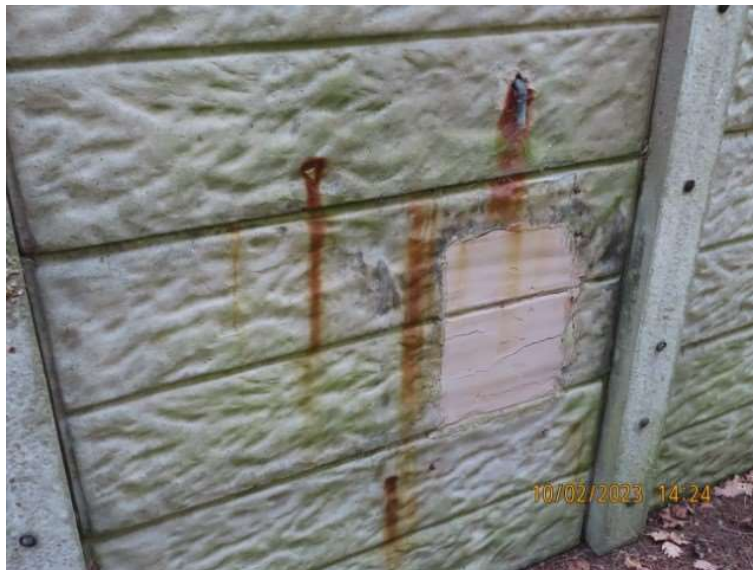
**JPEG No: IMG\_9090**

Infill to panel where boiler flue removed.

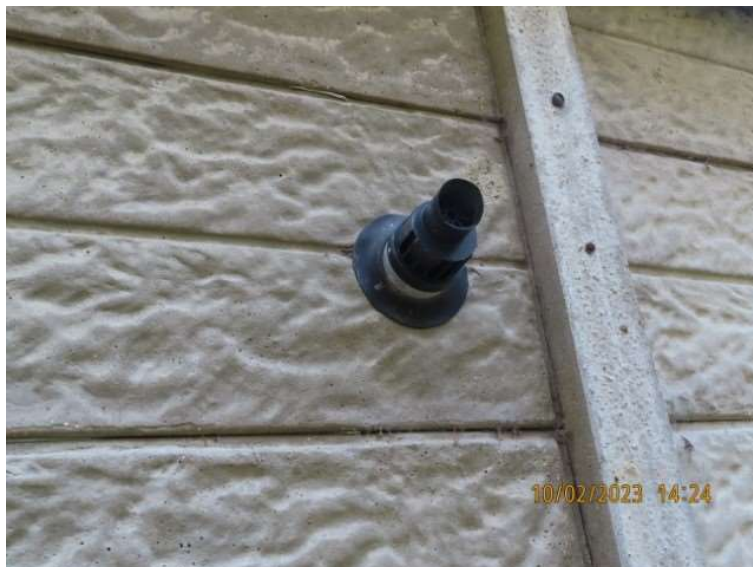
**JPEG No: IMG\_9091**

New boiler flue termination.

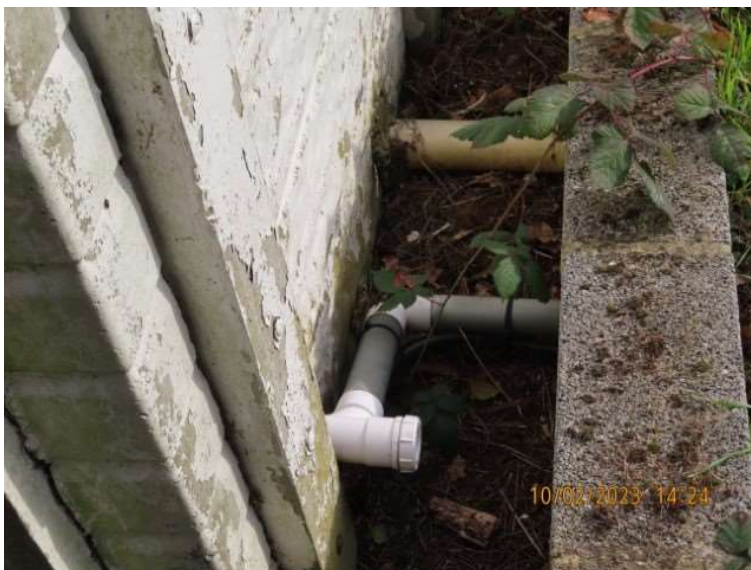
**JPEG No: IMG\_9092**

Exposed soil and waste pipe outlets to drainage chamber.

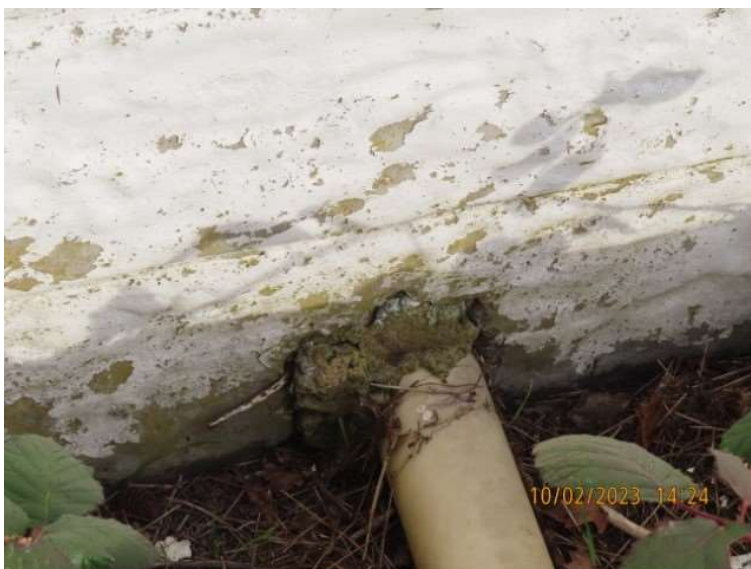
**JPEG No: IMG\_9093**

Crude infilling around soil pipe.

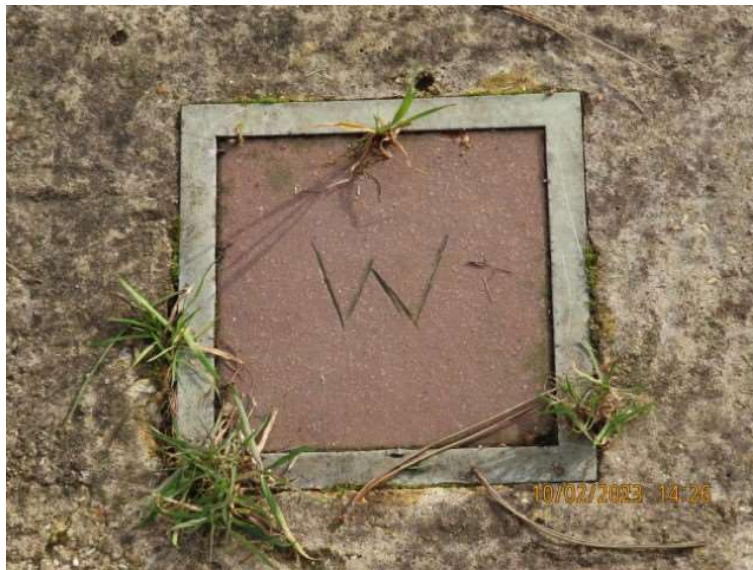
**JPEG No: IMG\_9111**

Stop valve position for water main.

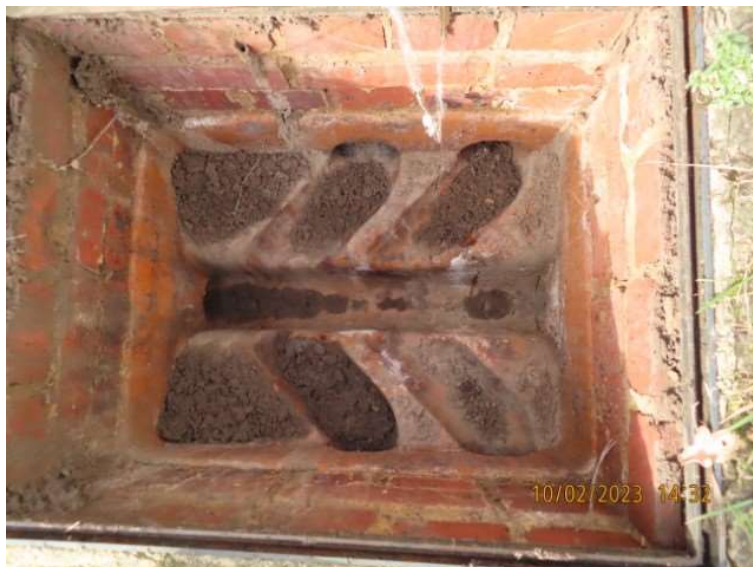
**JPEG No: IMG\_9112**

Interior of drainage inspection chamber with earth collected in branched outlets.

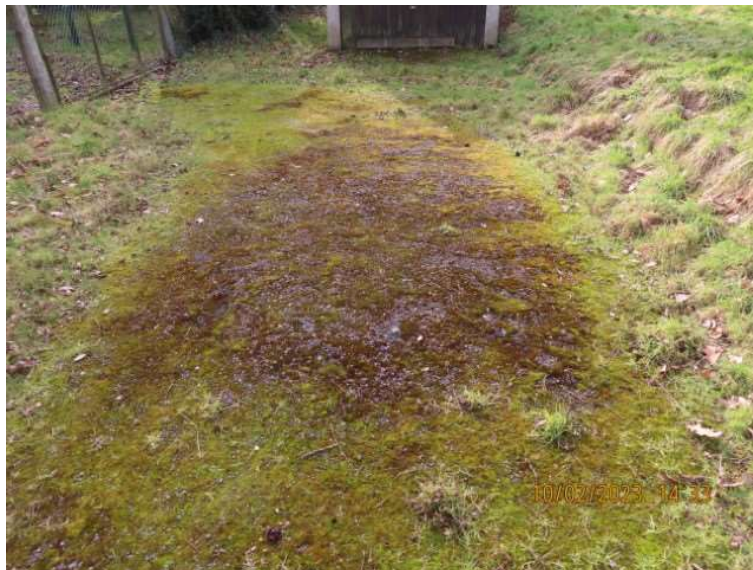
**JPEG No: IMG\_9113**

Overgrown moss and lichen on pathway.

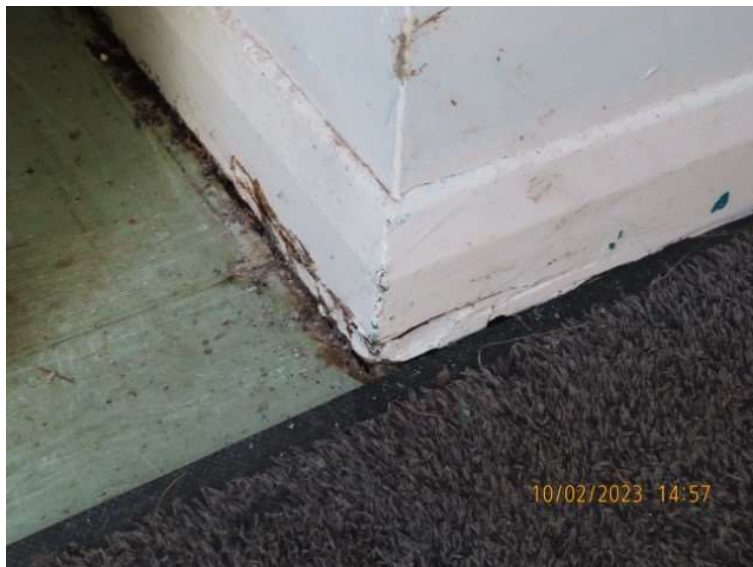
**JPEG No: IMG\_9116**

Decay on skirting near entrance door.

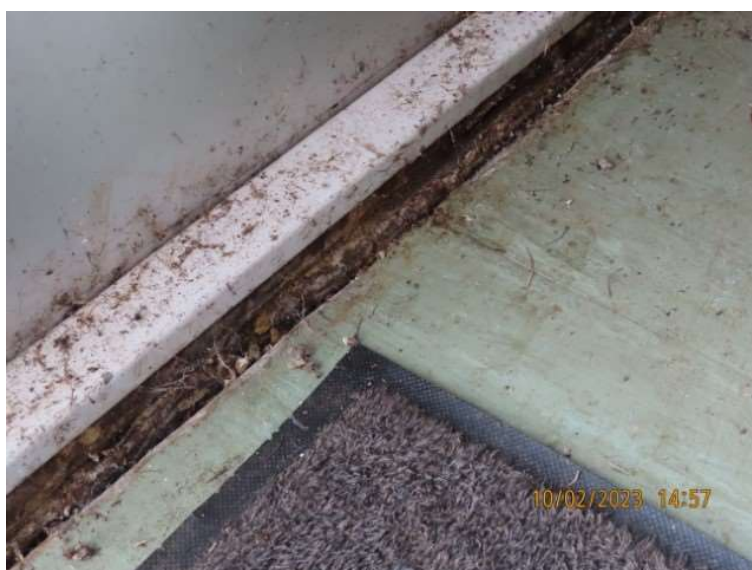
**JPEG No: IMG\_9119**

Damp flooring on entrance door threshold.
