## ■ Commercial Building Survey

Scout Hut  
Roestock Park  
Admiral Close  
Colney Heath  
Hertfordshire  
AL4 0QD

Friday 10<sup>th</sup> February 2023

Prepared by:  
**Brasier Freeth LLP  
Wentworth Lodge  
Great North Road  
Welwyn Garden City  
Hertfordshire  
AL8 7SR**

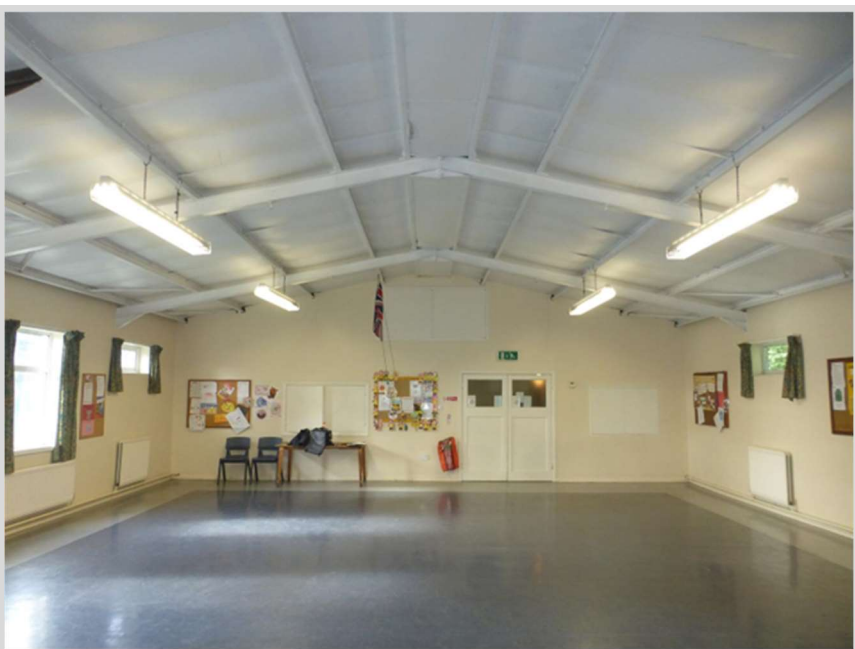
**PHOTO 15.1.1:**

Steel portal frame visible in hall, columns masked by internal wall finishes.

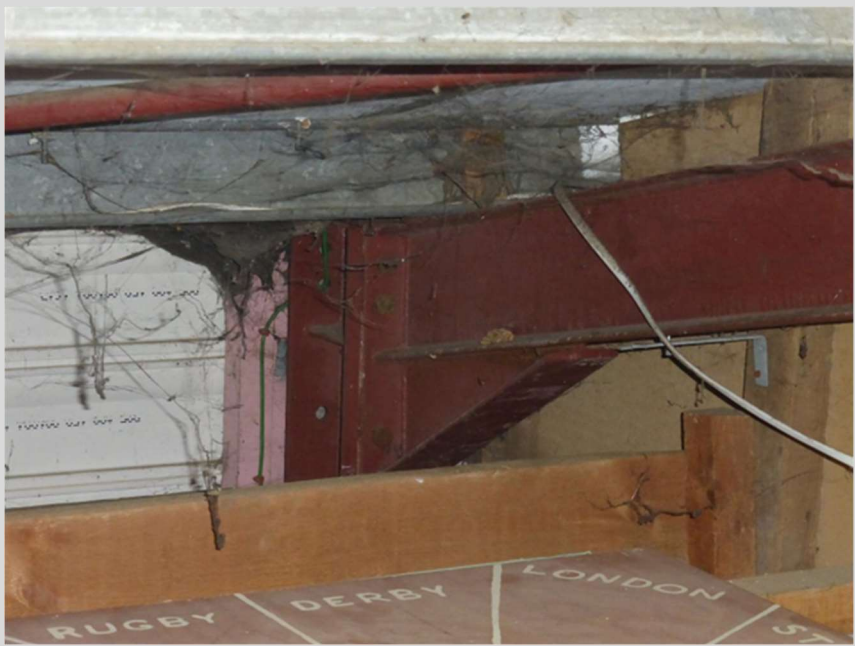
**PHOTO 15.1.2:**

- 15.1.2 We were unable to confirm how the steel portal frame connects to the concrete post and panel external wall system. Where visible in the roof void at eaves level there did not appear to be any bolts fixing the steel columns to the external wall system. Bolt fixings are visible externally to the concrete posts and it is assumed that they connect to the steel portal frame which is present on the inner side of the wall system, however we cannot confirm this.

Portal frame fixings to external concrete wall system not visible. No bolts present to visible holes in metal frame. Note: lack of insulation.

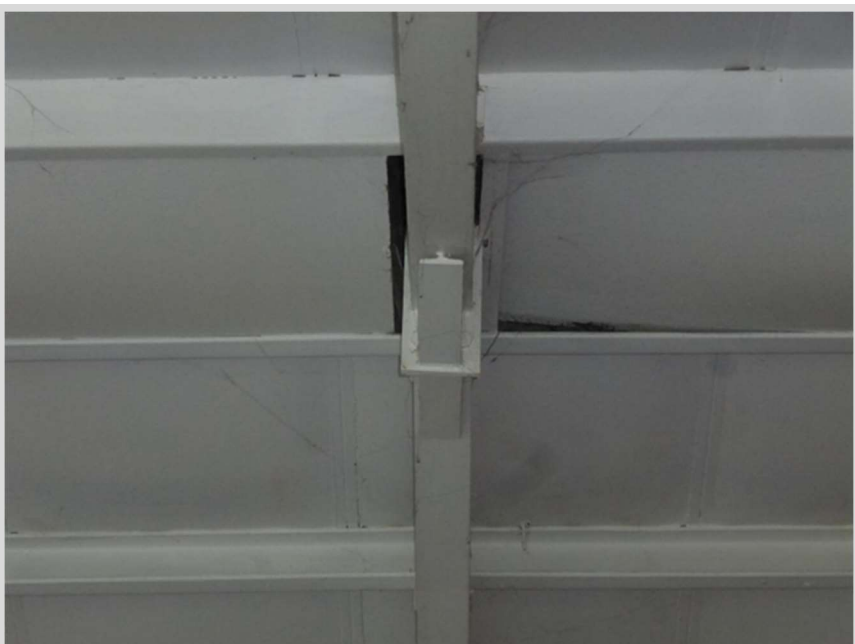
**PHOTO 15.1.3:**

- 15.1.3 Externally, there are no significant signs of movement with the roof and walls generally appearing uniform, however minor twisting movement is apparent internally to the steel portal frame and roof purlins in the hall. The areas where movement is apparent should be monitored and if further movement occurs then specialist advice should be obtained from a Structural Engineer.

Minor twisting of steel portal frame in hall at apex in centre requires monitoring.

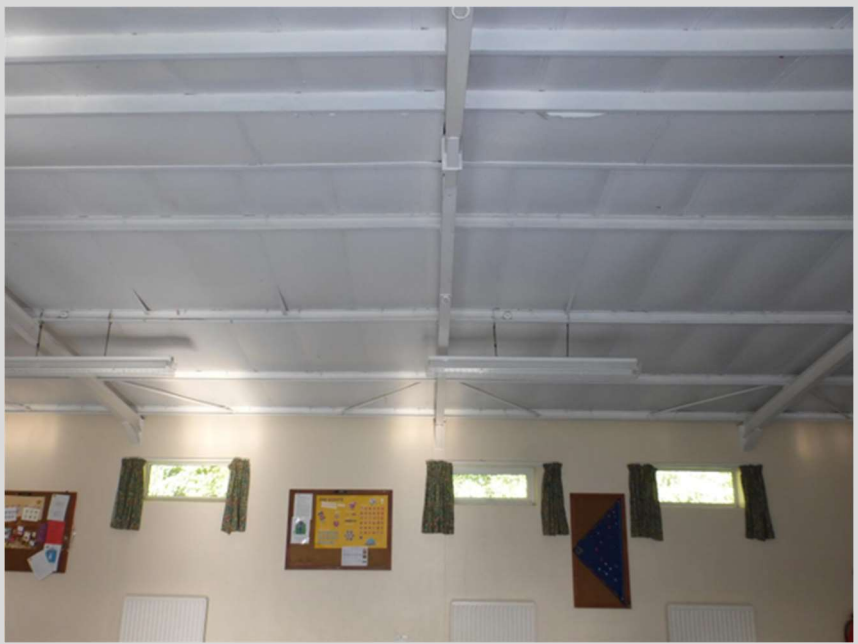
**PHOTO 15.1.3:**

Minor sagging to steel purlins in hall.

- 16.2.9 As noted in the Structural Frame Section. some of the steel purlins visible in the hall are sagging slightly between the steel portal frame and minor twisting is evident to the portal frame in the centre. The movement is relatively minor, however it is recommended that this is monitored and if any further movement occurs further advice should be sought from a Structural Engineer.

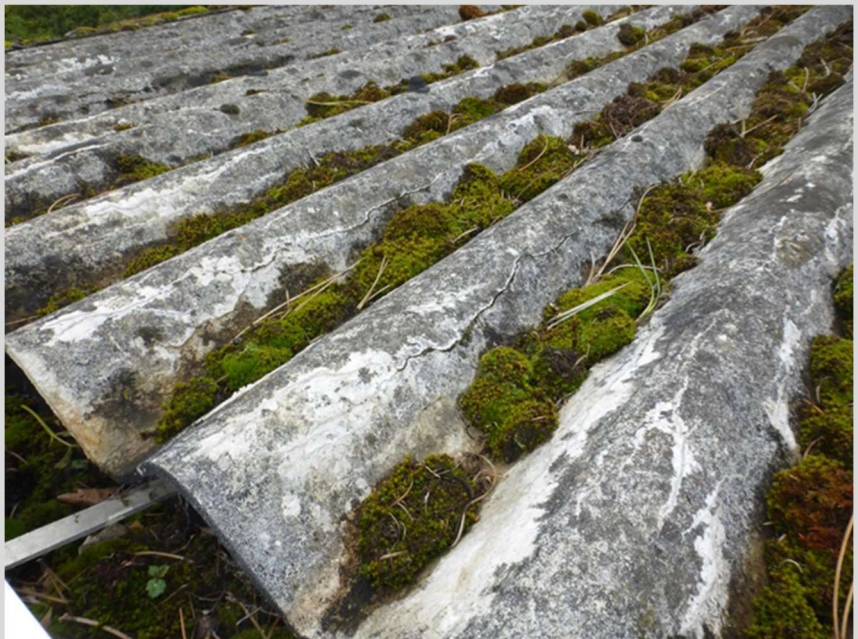
**PHOTO 16.2.1:**

- 1.1.5 Externally, the asbestos cement sheeting is covered with moss and other vegetation and the exposed areas are weathered and cracked with minor holes also noted in isolated locations. Some of the fixing bolts are displaced also. There is evidence of historic water ingress beneath the roof with old water staining to the internal finishes. In 2017 our report stated that *"considering the age and condition of the visible external roof coverings, it is likely they are approaching the end of their useful life. Replacement of the roof coverings or over cladding is recommended to prevent further water ingress and damage to the property and also to avoid ongoing reactive minor repairs which can be costly and are often unsuccessful."* In fairness, the roof does not appear to be significantly worse. Asbestos cement based sheet roofs are thought to have a life expectancy of up to sixty years at best. However, the rate of deterioration increases with age. When the outer surfaces become friable then the roof covering will need replacement.

Damaged surfaces and cracking to asbestos cement sheeting to roof slopes, moss growth and vegetation present on sheeting.

- 1.3.1 Remove moss growth and seal holes to roof.
- 1.3.2 Improve ventilation and upgrade insulation to roof void with installation of vents within cladding to gable end.
- 1.3.3 Install mechanical extraction to WC's and kitchen.
- 1.3.4 Clear and overhaul rainwater goods.
- 1.3.5 Fill cracks to ceilings and walls and monitor for further movement.
- 1.3.6 Repair damaged concrete post adjacent to entrance door.
- 1.3.7 Redecorate internally and externally.
- 1.3.8 Clear moss from paths and prune vegetation.

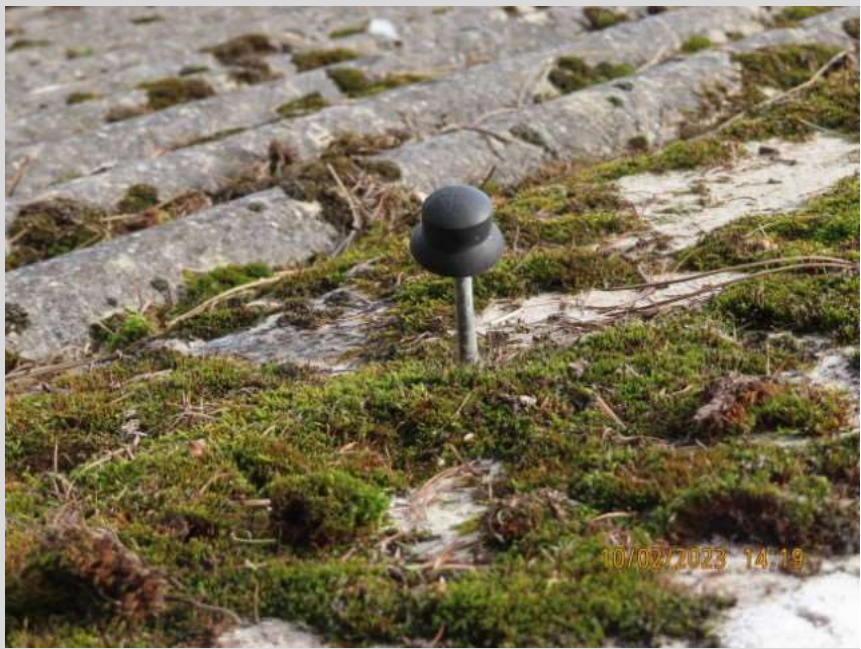
**PHOTO 16.2.2:**

Bolt fixings corroded and displaced.

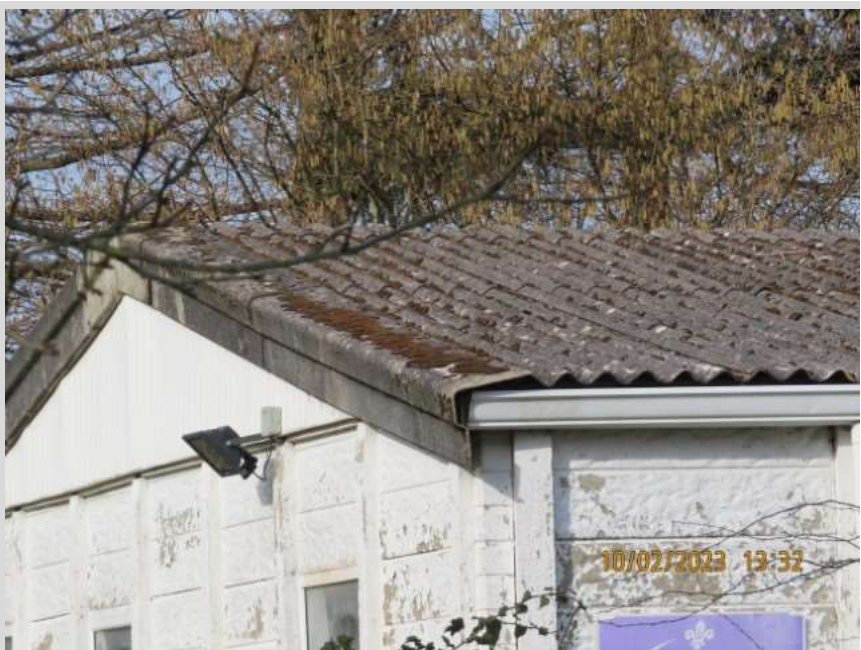
**PHOTO 16.2.3:**

- 16.2.3 Since 2017 we believe the verges have been replaced as they appear to be in better condition, although in some areas the verges are slightly misaligned and displaced.

Misaligned verge capping.

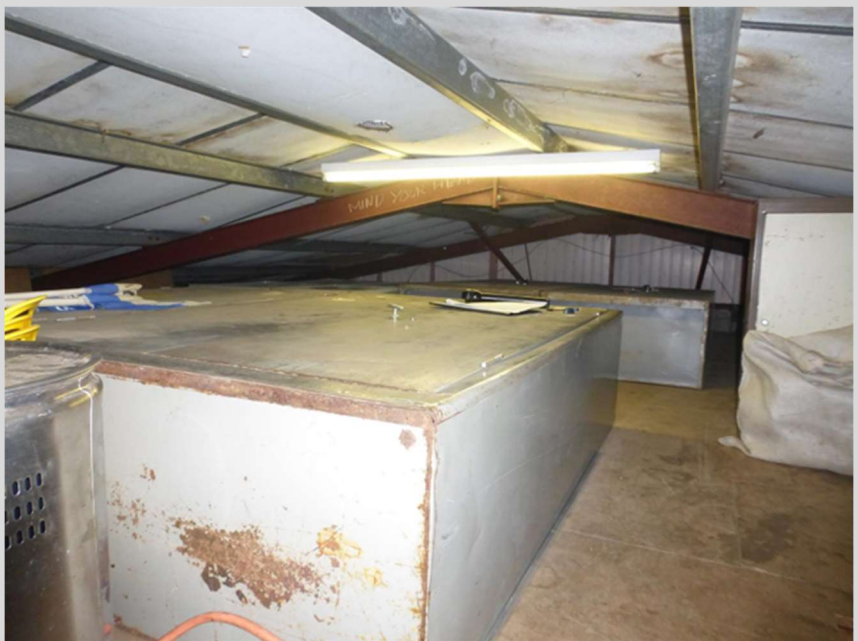
**PHOTO 16.2.6:**

Stored goods within roof void, various stains and marks to internal boarding to underside of roof slopes.

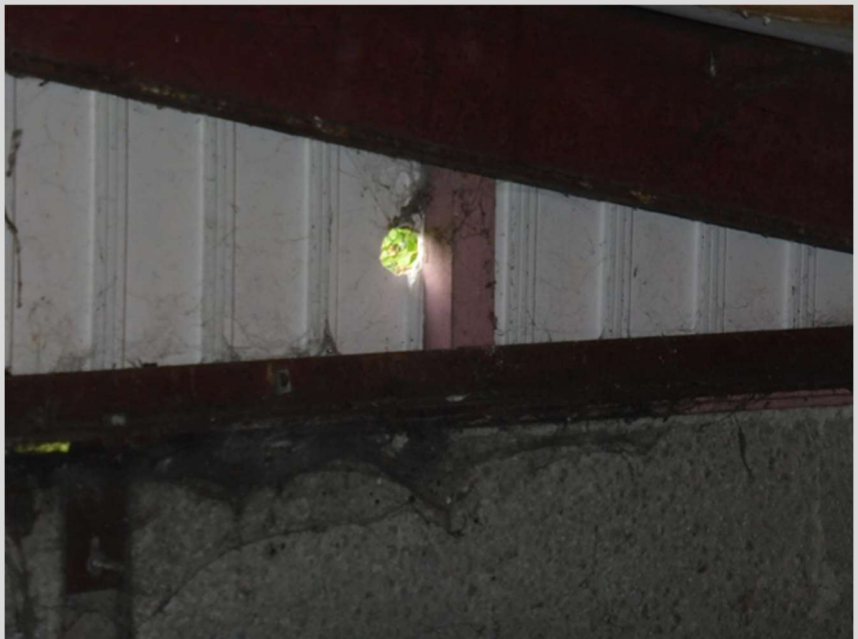
**PHOTO 16.2.7:**

Hole noted to cladding to left hand elevation.

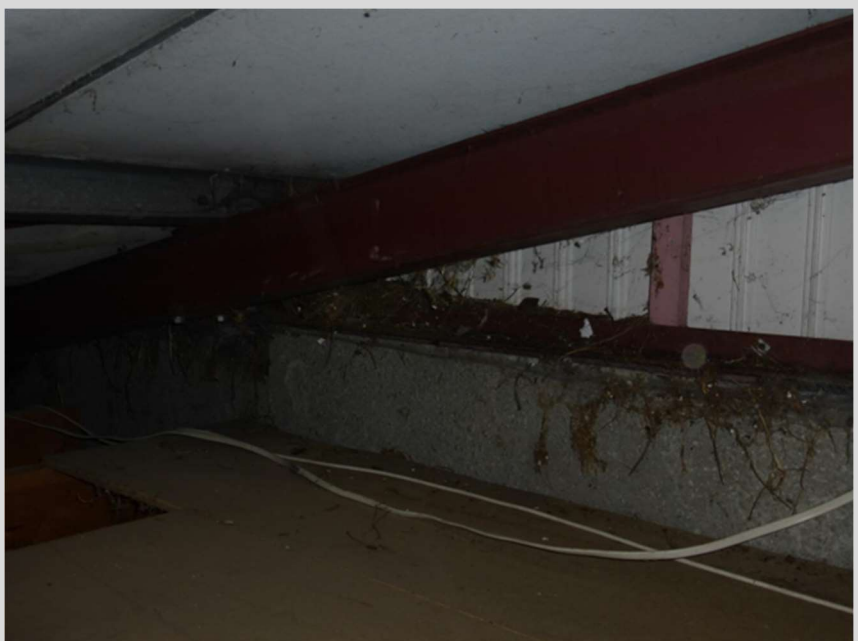
**PHOTO 16.2.8:**

- 16.2.8 There is evidence of a bird's nest within the roof void to the front corner, although we are unable to confirm whether the nest is active. You should be aware that birds' nests are protected by law and care should be taken if works are carried out ensuring any active nests are not disturbed or destroyed.

Suspected bird's nest within roof void to front left and side.

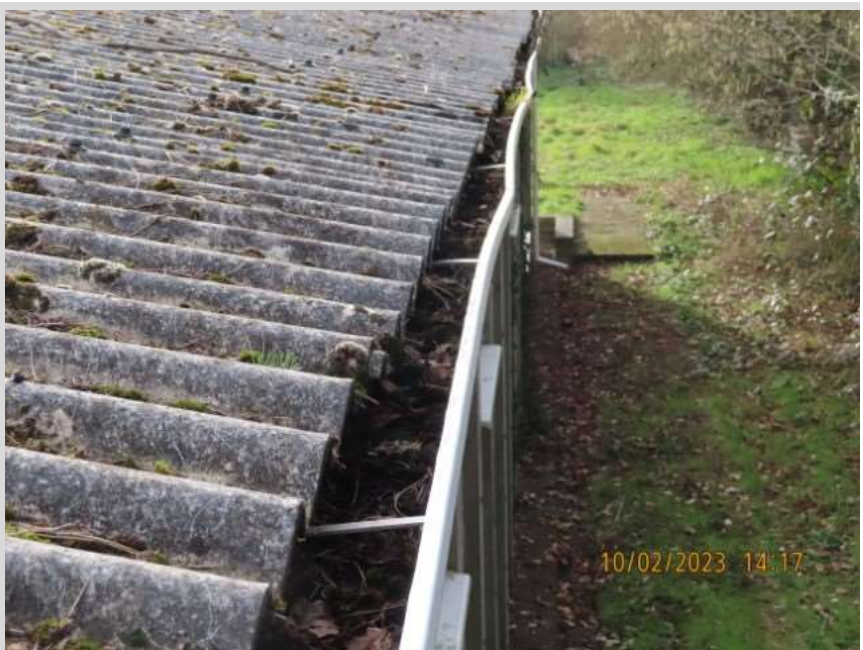
**PHOTO 17.2.2:**

Misaligned rear gutter.

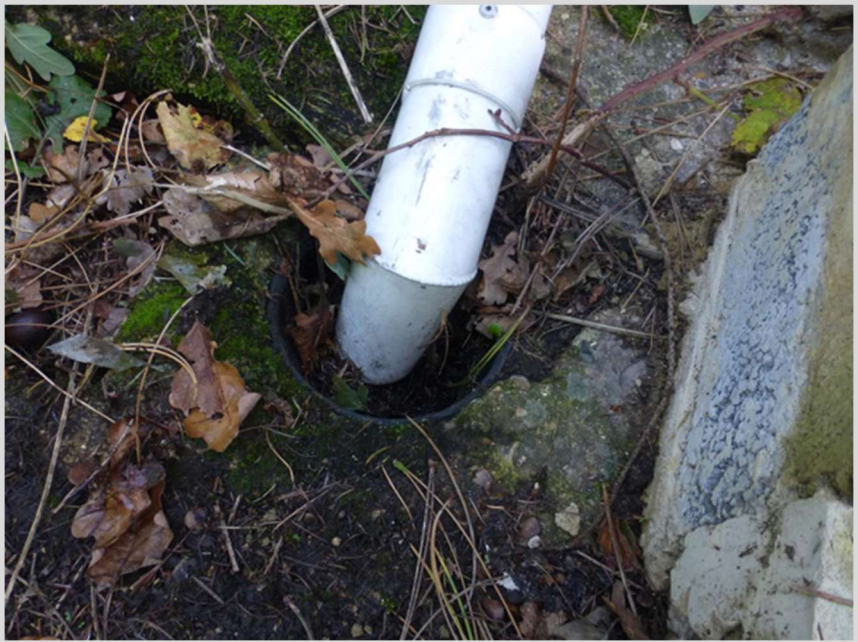
**PHOTO 17.2.3:**

- 17.2.3 The rainwater gullies are not provided with gratings allowing dirt and debris to fall into the gullies. The gullies and downpipes should be cleared of all blockages and gratings provided to gullies to prevent future blockages.

Rainwater downpipes discharging to oversized gullies which are not provided with gratings. Gratings to be provided to prevent future blockages.

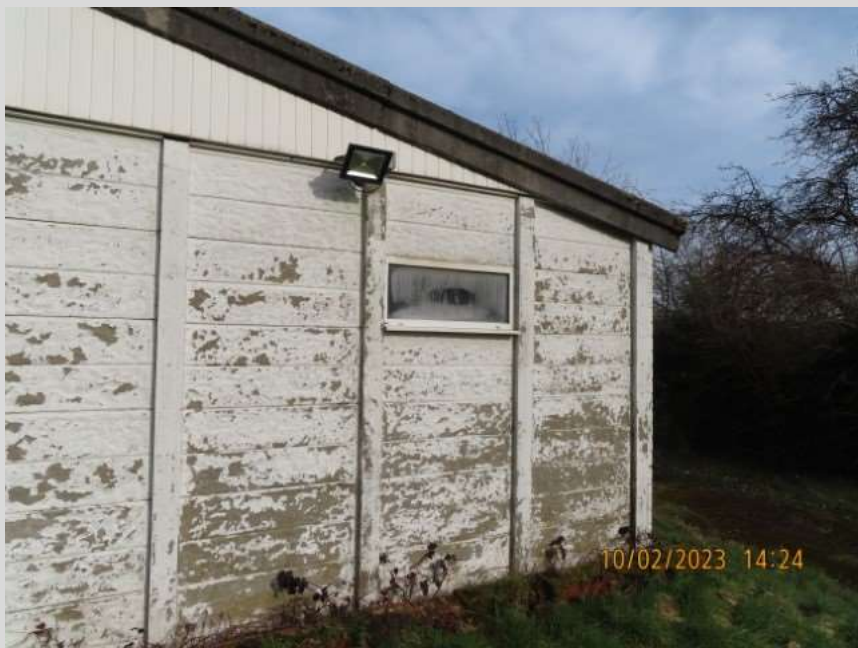
**PHOTO 18.2.1:**

Prefabricated concrete post and panel system painted finishes externally forming walls to Scout Hut with discoloured finishes.

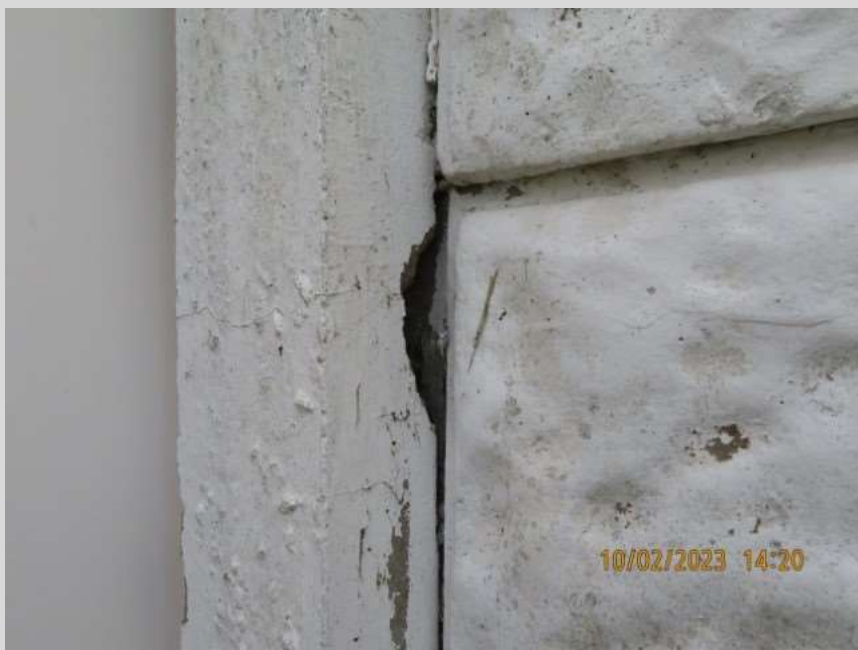
**PHOTO 18.2.2:**

Minor damage to concrete post adjacent to double entrance doors requires repair, no significant movement noted.

- 18.2.2 The damaged concrete post adjacent to the entrance doors should be repaired to prevent water entry and further deterioration of the frame or water ingress.

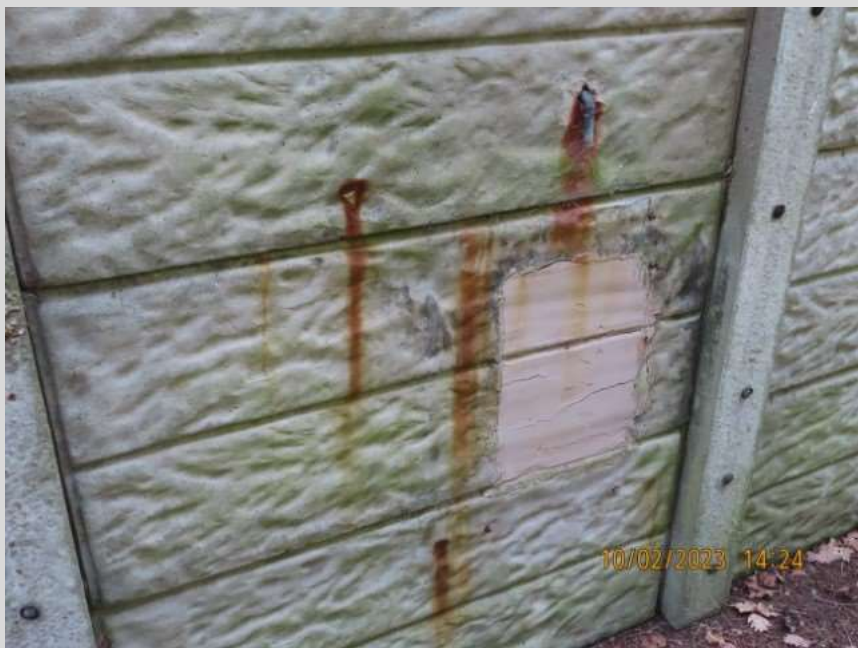
**PHOTO 18.2.4:**

Old boiler flue aperture on concrete post and panels to rear elevation unfinished, previous penetrations appear to have been filled with cracking and staining evident externally.

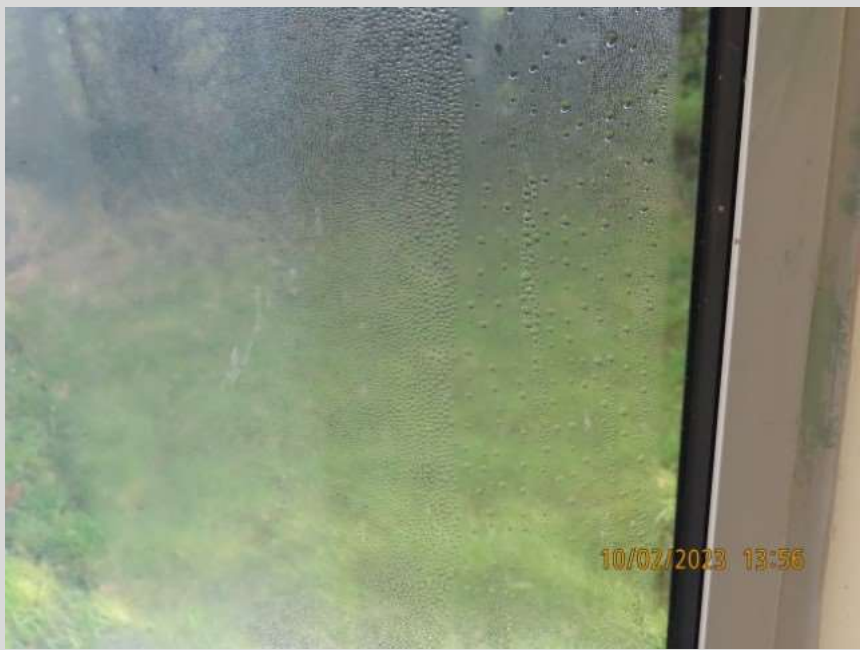
**PHOTO 19.2.1:**

Condensation to window units.

19.2.3 It is recommended that all defective double glazed units are replaced. Ideally, sealed glass units should be installed with toughened glass, if necessary.

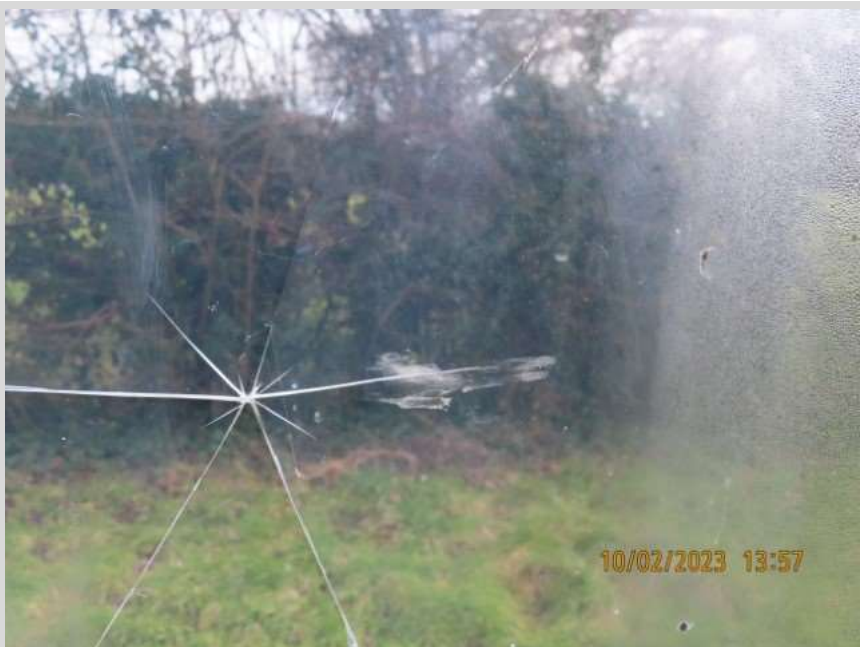
**PHOTO 19.2.4:**

Cracked perspex glazing.

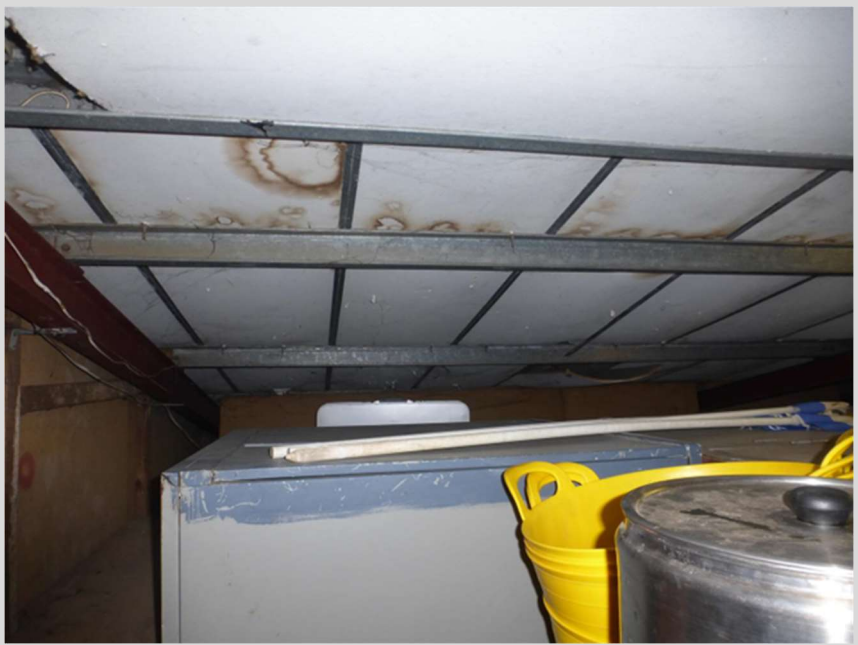
**PHOTO 21.2.1:**

Staining to underside of roof slope within roof void. Various fibre board panels are displaced. Paper lining contains asbestos.

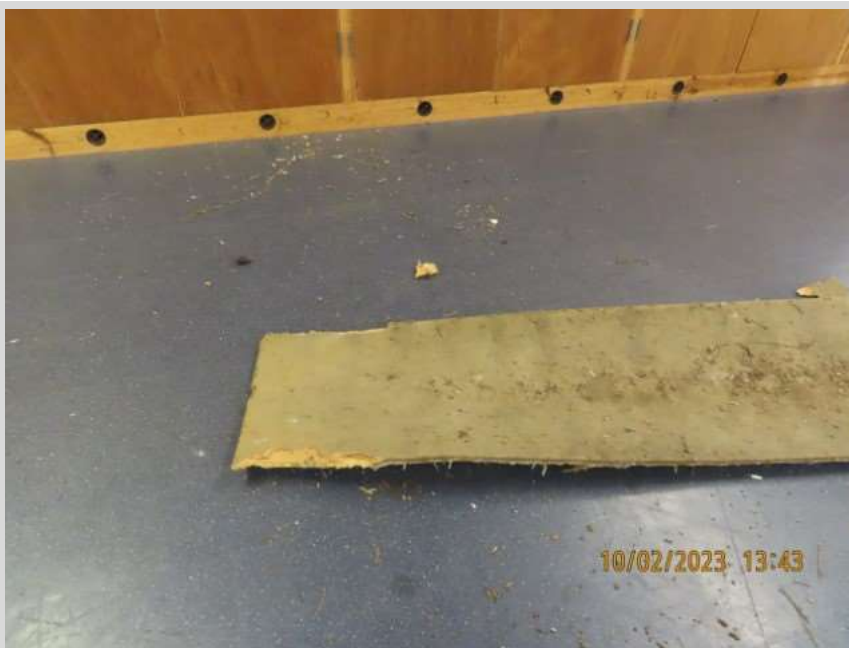
**PHOTO 21.2.1:**

Fibre ceiling panel on  
floor.

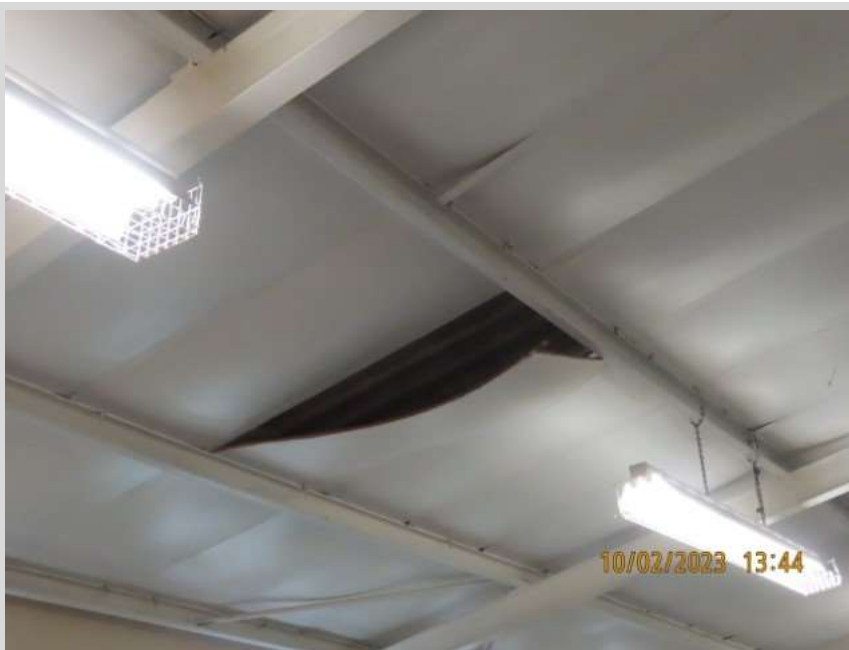
**PHOTO 21.2.1:**

Bowing ceiling panel.

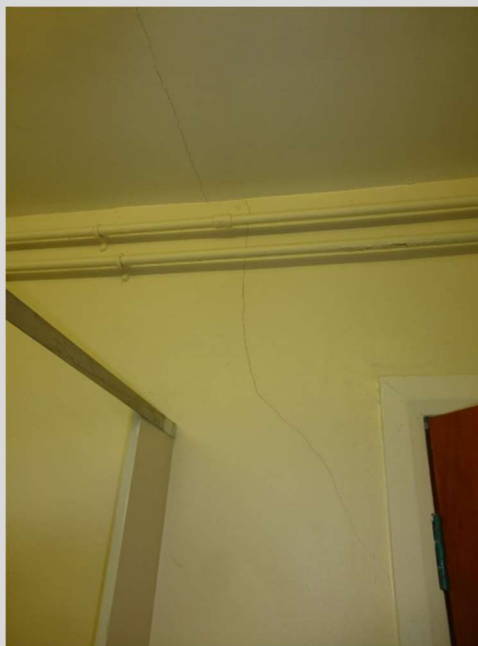
**PHOTO 21.2.3:**

2017 Photo – Cracking  
to plasterboard in female  
WC corresponding with  
diagonal cracking to  
adjacent wall next to  
door opening.

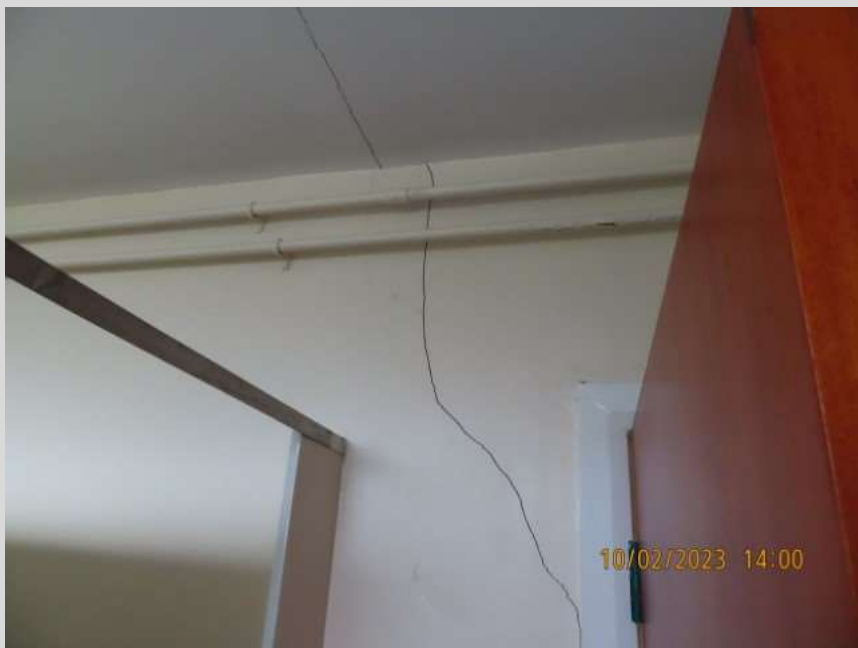
**PHOTO 21.2.3:**

2023 Photo – Note: the cracks seem wider and more pronounced.

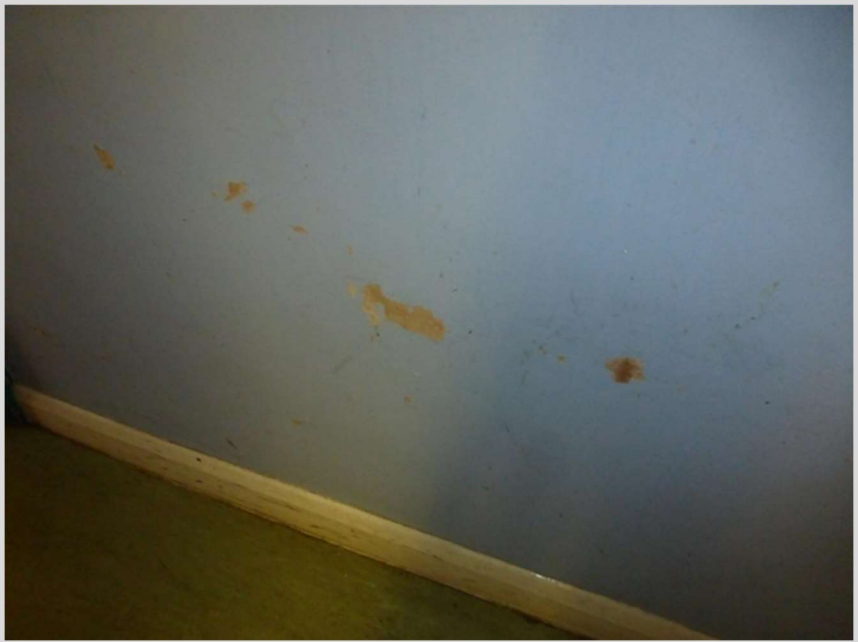
**PHOTO 22.2.4:**

Minor moisture detected to walls within kitchen area with painted finishes flaking. No ventilation provided to kitchen.

- 22.2.5 It is recommended that ventilation be introduced to the kitchen to remove moisture and prevent condensation and that timber skirtings in the areas where floors are cleaned with water are replaced with waterproof skirtings.
- 22.2.6 The walls generally appear to be stable, the cracks are likely to be explained by shrinkage movement in the blockwork masonry.
- 22.2.7 Generally, moisture meter readings revealed that the walls are essentially dry but, some dampness exists at the junction of the wall and floor interface near the entrance doors.

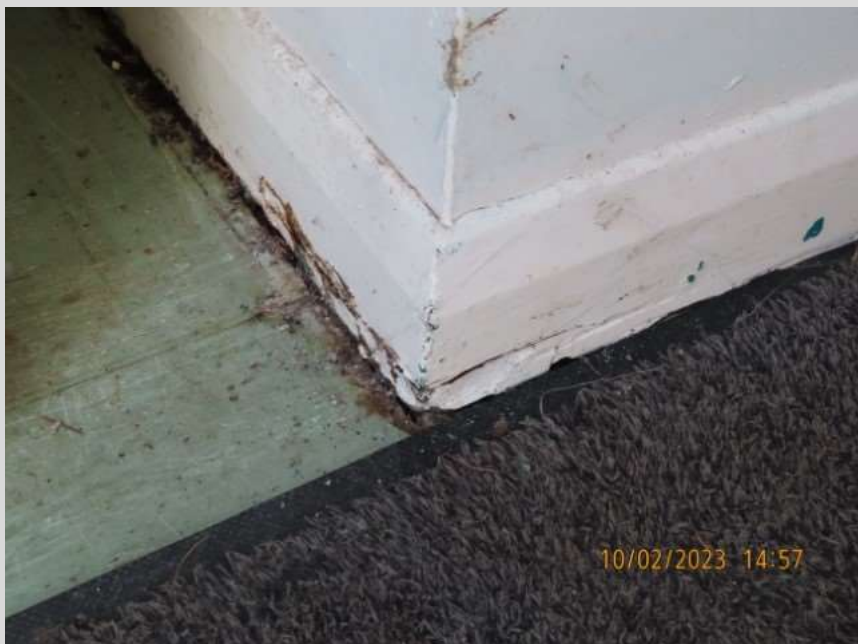
**PHOTO 22.2.7:**

Damp skirting with signs of decay in entrance lobby.

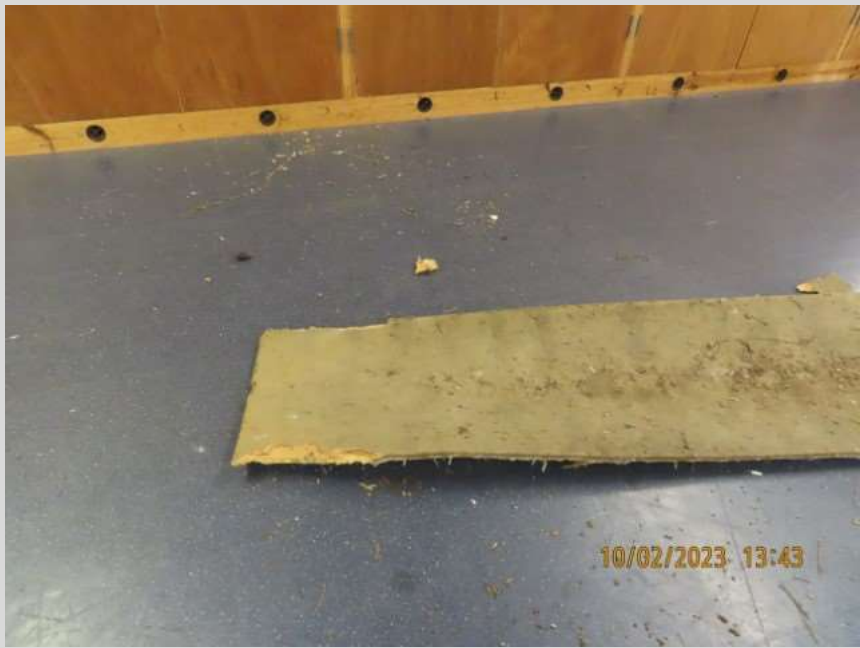
**PHOTO 23.2.1:**

Worn vinyl flooring.

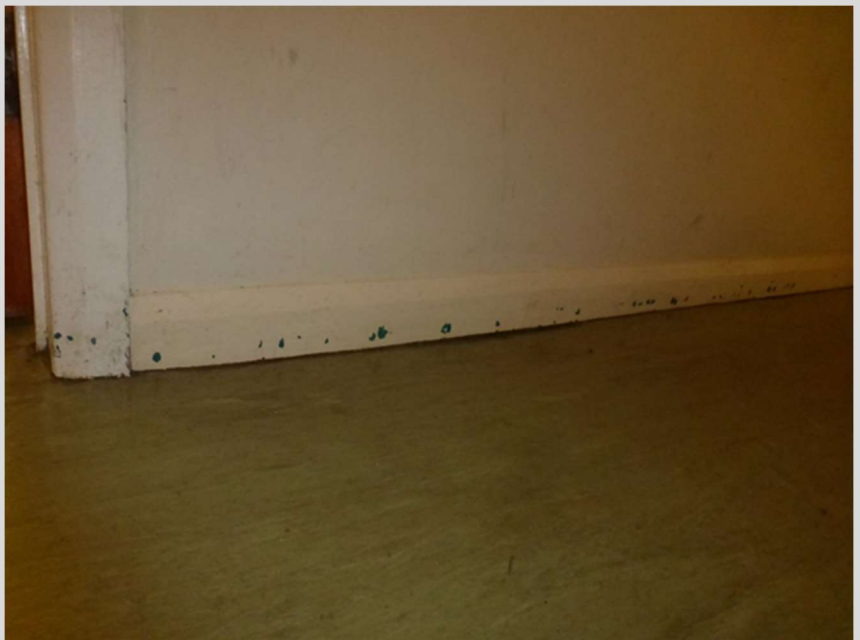
**PHOTO 23.2.2:**

- 23.2.2 The solid floors to the other rooms are slightly uneven in areas, particularly adjacent to the door into the Leader's Room and adjacent to the wall between the female WC's and access corridor where gaps were noted between the floor and timber skirtings, suggesting that the floors may have dropped.

Gaps noted beneath skirtings to walls between the corridor and female WC and the corridor and Leader's Room, suggesting minor movement.

- 23.2.4 It is recommended that the areas where the floor appears to have dropped slightly are monitored to ensure that future movement does not go unnoticed and to confirm whether the movement is progressive or historic. If further movement does occur, then further advice should be sought. If and when floor finishes are replaced in future the exposed floor structures should be carefully inspected and any necessary repairs carried out prior to application of new floor finishes.

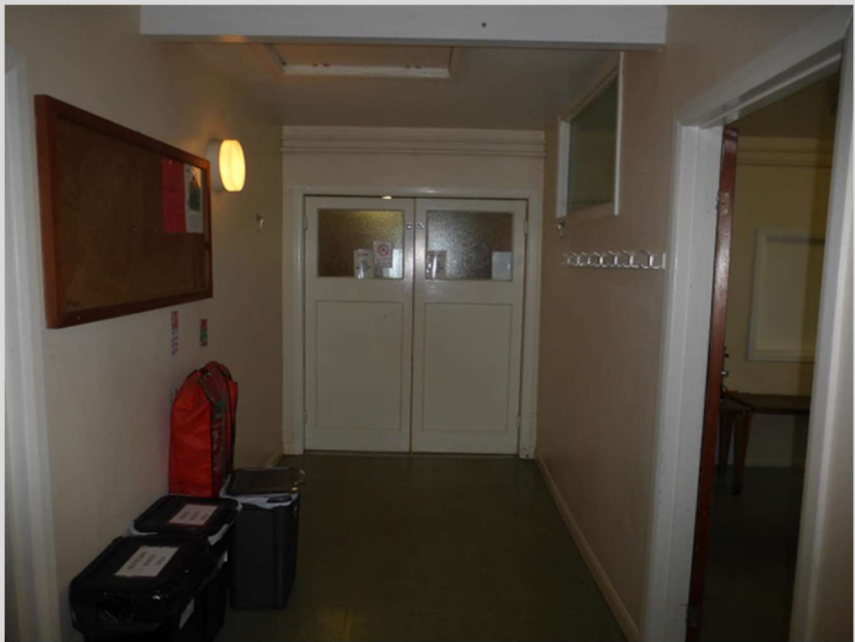
**PHOTO 24.2.1:**

Double doors from corridor into hall are not fire rated and are not provided with intumescent seals or closers.

- 1.4.4 Replace internal doors with fire rated doors, smoke and intumescent seals and closers.
- 1.4.5 Install central mains powered fire alarm.
- 1.4.6 Improve emergency lighting and fire escape signage.

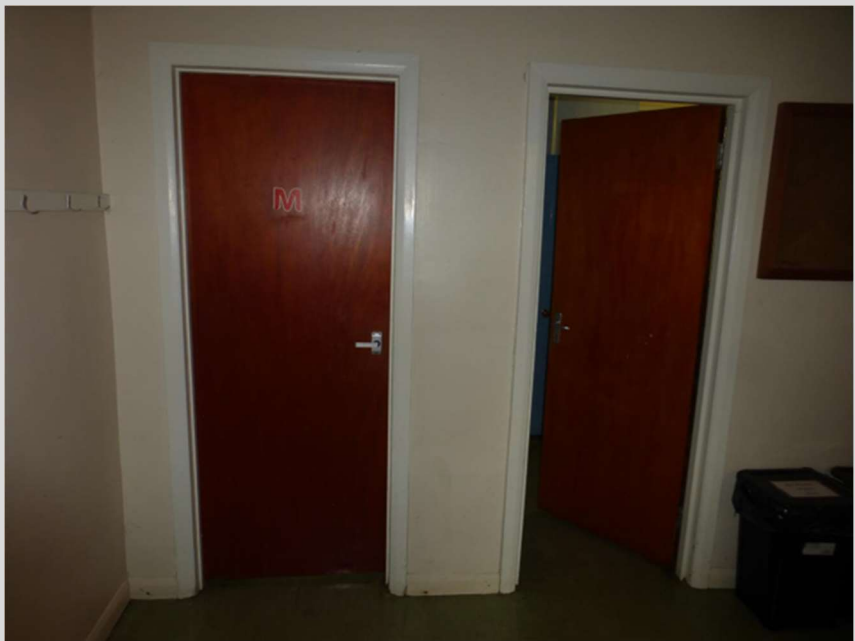
**PHOTO 24.2.1:**

Lightweight single internal flush doors are not fire rated or provided with intumescent seals or closers.

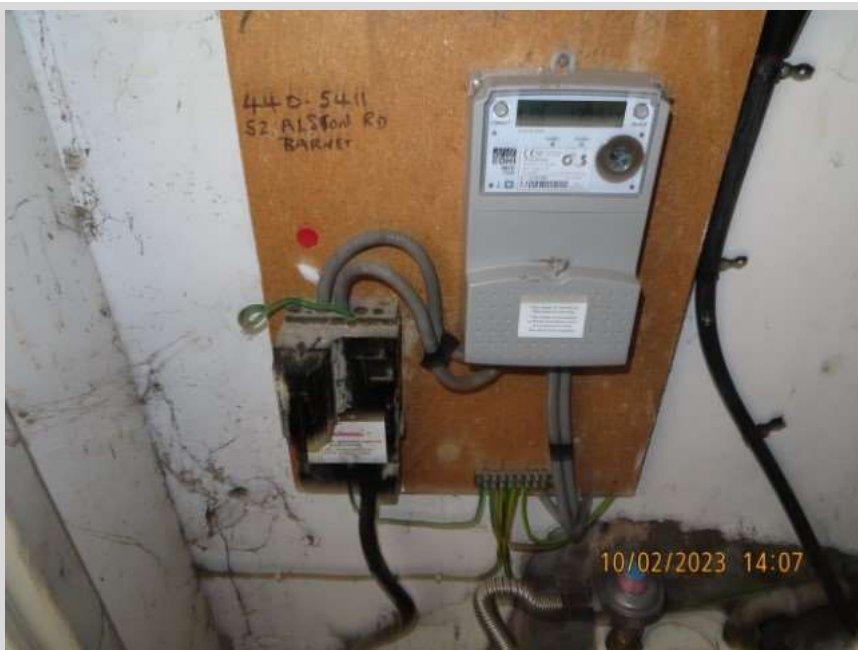
**PHOTO 26.1.2:**

Electricity intake meter and consumer unit located within timber housing in male WC to left hand rear corner.

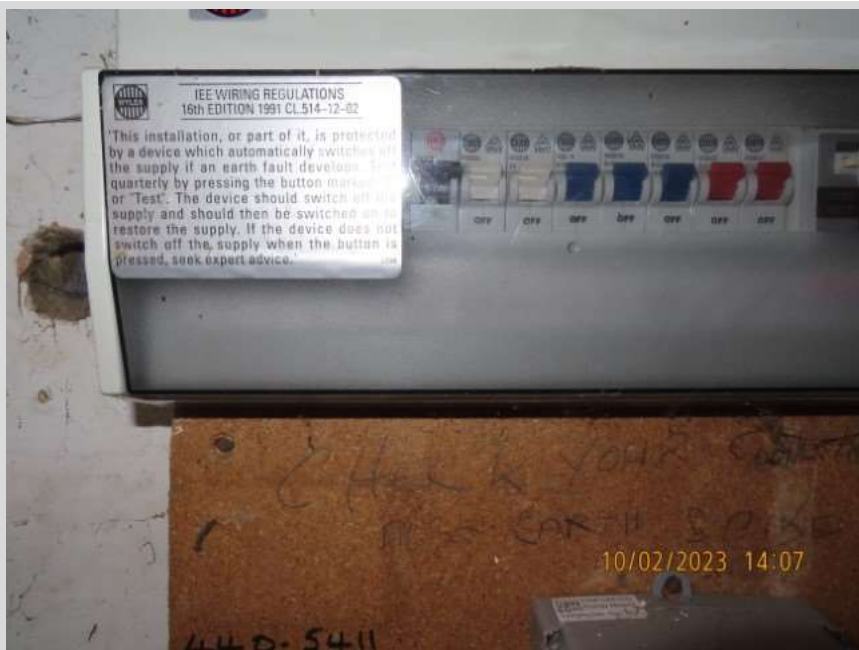
JPEG No: IMG\_9037

Modern consumer unit provided with RCD protection; circuits are also labelled. No evidence of recent testing.

- 26.1.5 It is recommended that the electrical installation be tested every 5 years by a qualified electrician. If this is not available, then we recommend that the electrical installations be checked by a qualified electrician, preferably someone who is registered with the NICEIC and any advice or recommendations raised should be followed.

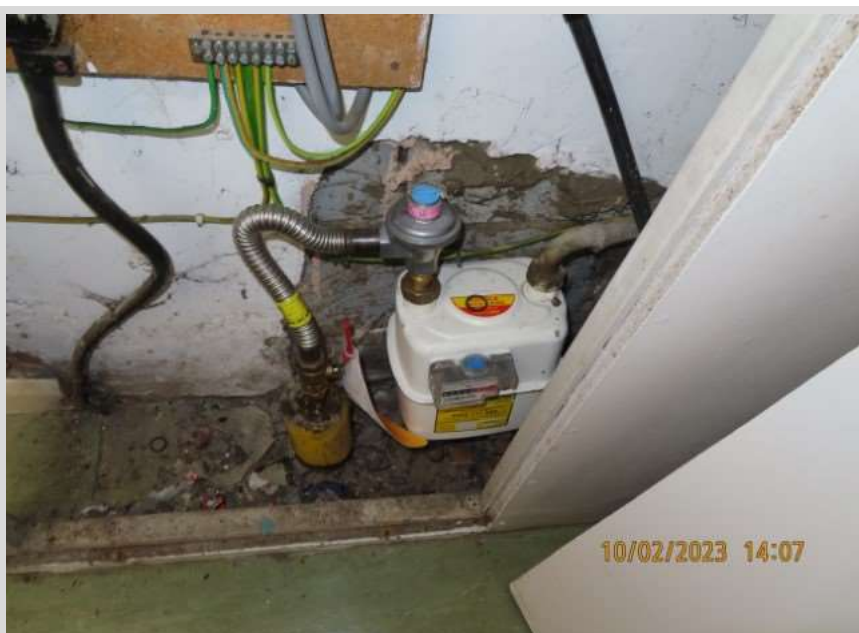
JPEG No: IMG\_9039

Gas meter located within timber housing in male WC adjacent to electricity intake, earth bonding evident.

- 27.1.2 We have not tested the gas supply, however it may be prudent to obtain gas installation certificates, maintenance or servicing reports.

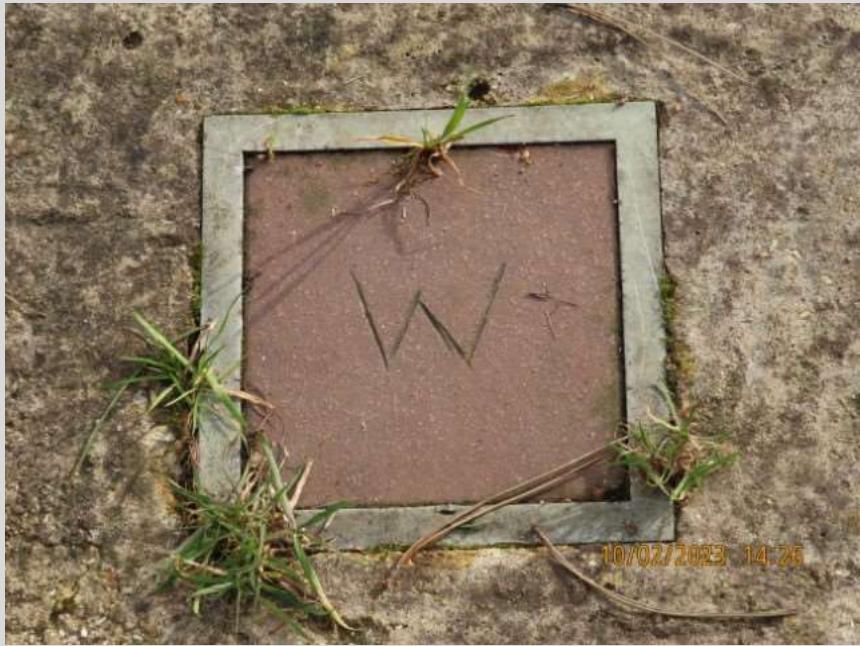
**PHOTO 28.1.1:**

External stop valve to water located to left side of property within concrete path.

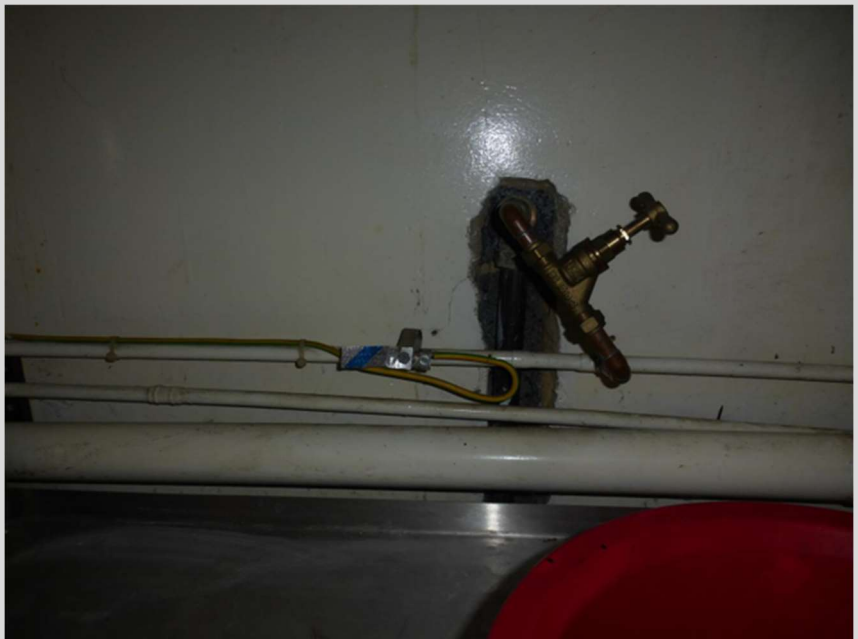
**PHOTO 28.1.2:**

Second cold water stop valve located within kitchen to rear wall at low level.

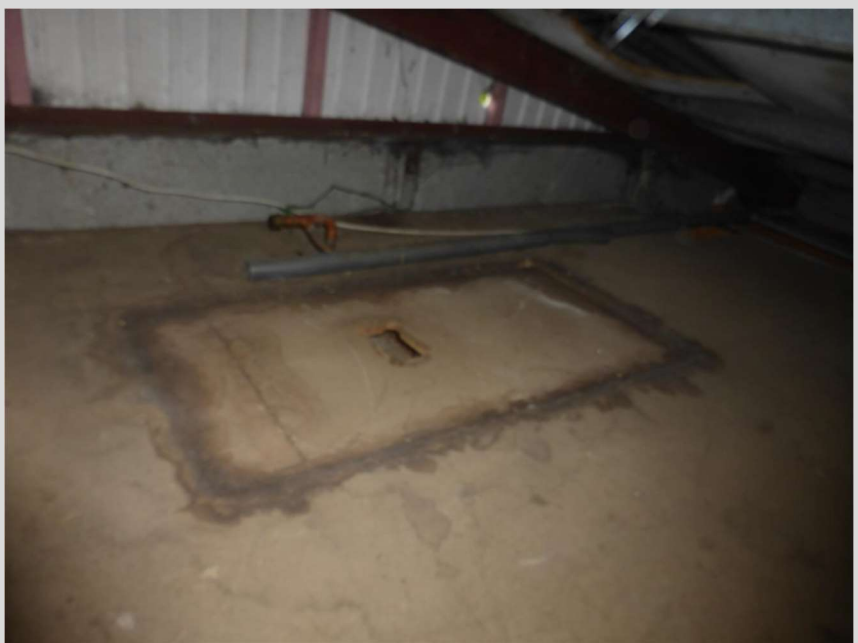
**PHOTO 28.1.3:**

- 28.1.3 There is no cold water storage visible within the property, however from our inspection of the roof void it would appear that a previous cold water tank has been removed. It is, therefore assumed that cold water to the sanitary fittings are mains fed. The water pressure from the sanitary fittings generally appeared adequate where tested.

Former cold water tank within roof void appears to have been removed with staining noted to boarding in roof space and redundant pipework present.

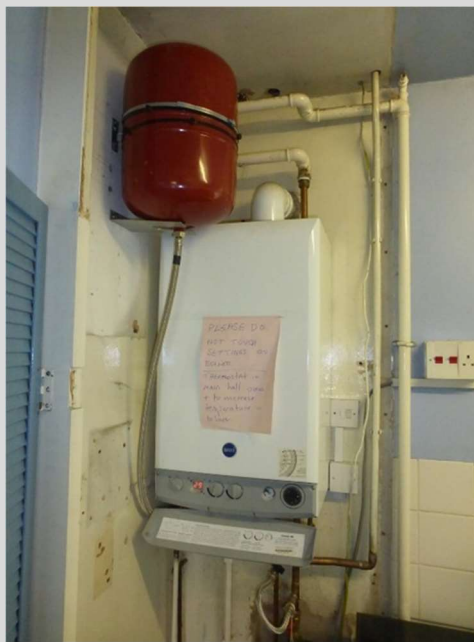
### **PHOTO 29.1.1:**

Gas fired combination boiler originating to pressure vessel, located within kitchen.

- 29.1.2 The gas boiler appears to have been relatively recently replaced, however there is no evidence of testing. It is recommended that you obtain copies of any test certificates and also any warranties that may exist for the boiler and heating installation.
- 29.1.3 The water supply pipework to the boiler is provided with a magnetic anti-scale system and a Fernox TF1 filter.

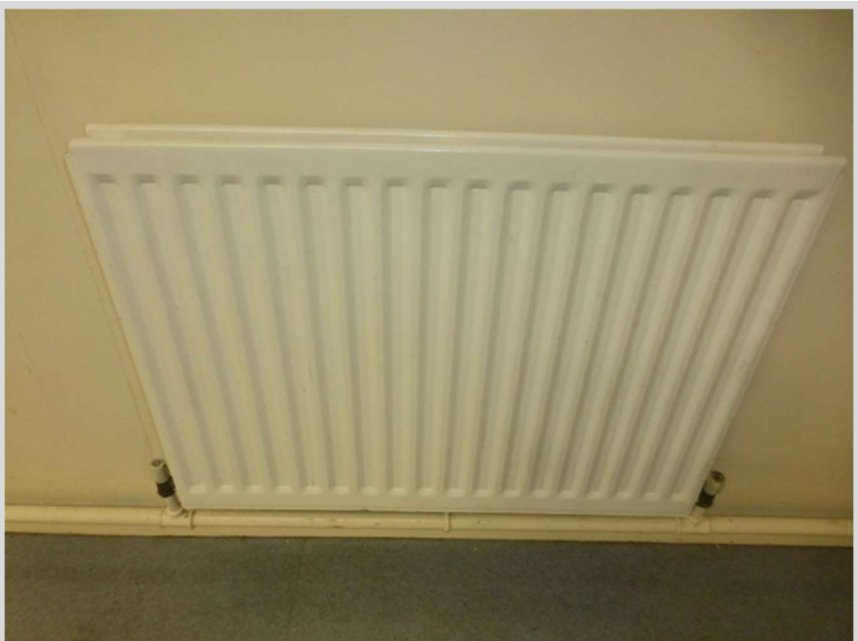
**PHOTO 29.1.5:**

- 29.1.4 Hot water is provided to the sink within the kitchen, however there is no hot water supply to the wash hand basins in the male and female WC's with only cold water available. You may wish to consider provision of hot water to the WC's in future.
- 29.1.5 The radiators throughout the property are not provided with thermostatic radiator valves, therefore it is not possible to control them independently. The painted finishes to the radiators are scuffed in various locations and some of the brackets to the low level pipework distributing the hot water are also noted to be displaced. It is recommended that any displaced radiators or pipes are re-fixed.

Pressed steel panel  
radiators providing  
space heating  
throughout the property.
