## ■ Commercial Building Survey

Scout Hut  
Roestock Park  
Admiral Close  
Colney Heath  
Hertfordshire  
AL4 0QD

Friday 10<sup>th</sup> February 2023

Prepared by:  
**Brasier Freeth LLP  
Wentworth Lodge  
Great North Road  
Welwyn Garden City  
Hertfordshire  
AL8 7SR**

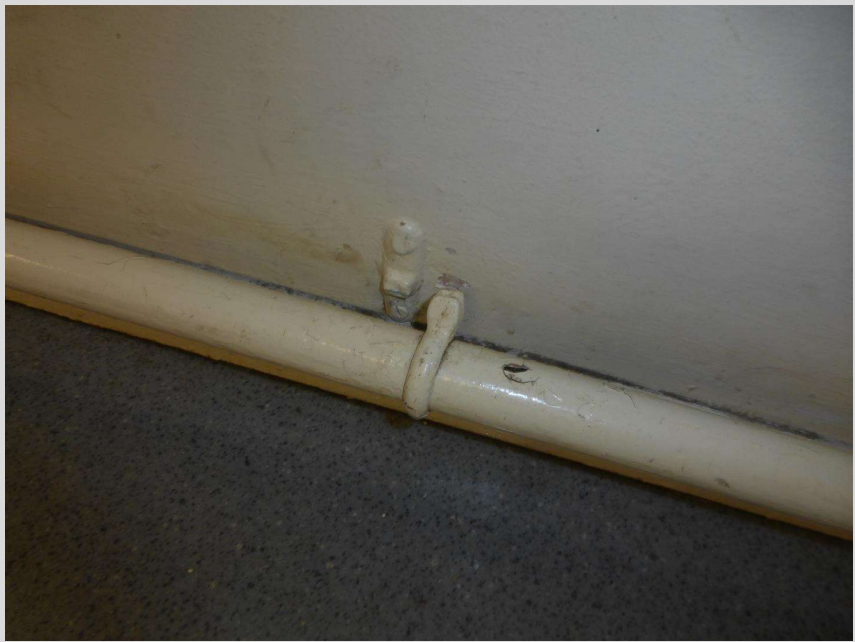
**PHOTO 29.1.5:**

Distribution pipework for wet heating system with painted finishes, various brackets are damaged and require replacement.

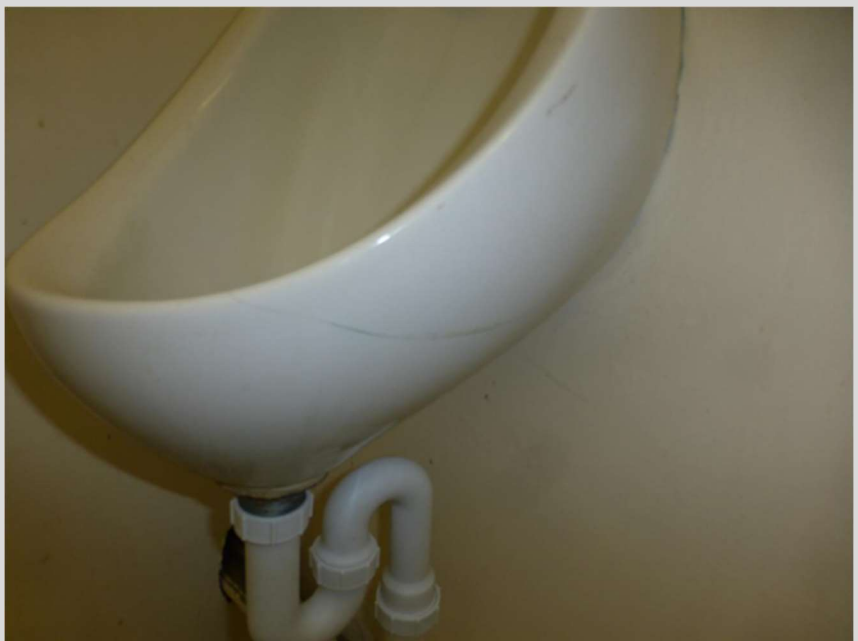
**PHOTO 31.1.1:**

- 31.1.1 The sanitary fittings appear basic and dated but, are generally functional. A minor crack was noted to one of the urinals in the male WC's which will require replacement in the near future.

Minor cracking noted to  
urinal in male WC.

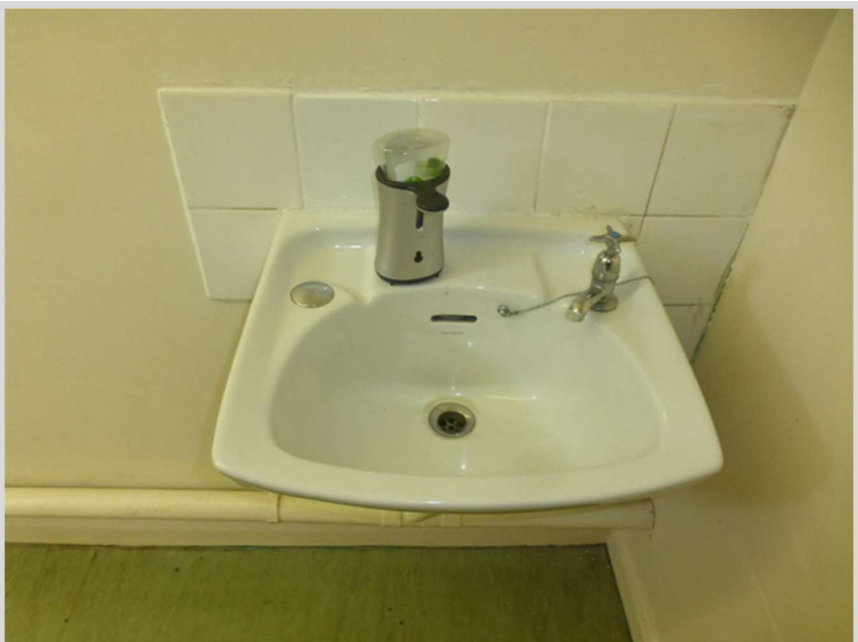
**PHOTO 31.1.1:**

Sanitary fittings  
functional but, dated. No  
hot water provided to  
wash hand basins in  
WC's.

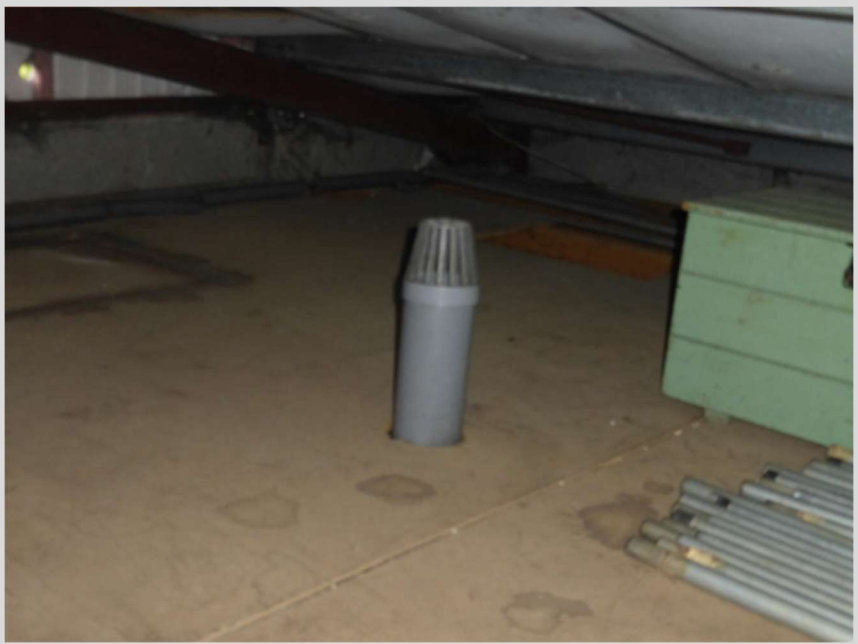
**PHOTO 31.1.2:**

Soil and vent pipe terminates within roof void which is poorly ventilated. No air admittance valve allowing odours to vent into void.

- 31.1.2 The soil and vent pipe is located in the male WC's and it terminates within the roof void above, however it is not provided with an air admittance valve. It is recommended that an air admittance valve be installed to prevent smells and odours venting into the roof void, which is also poorly ventilated.

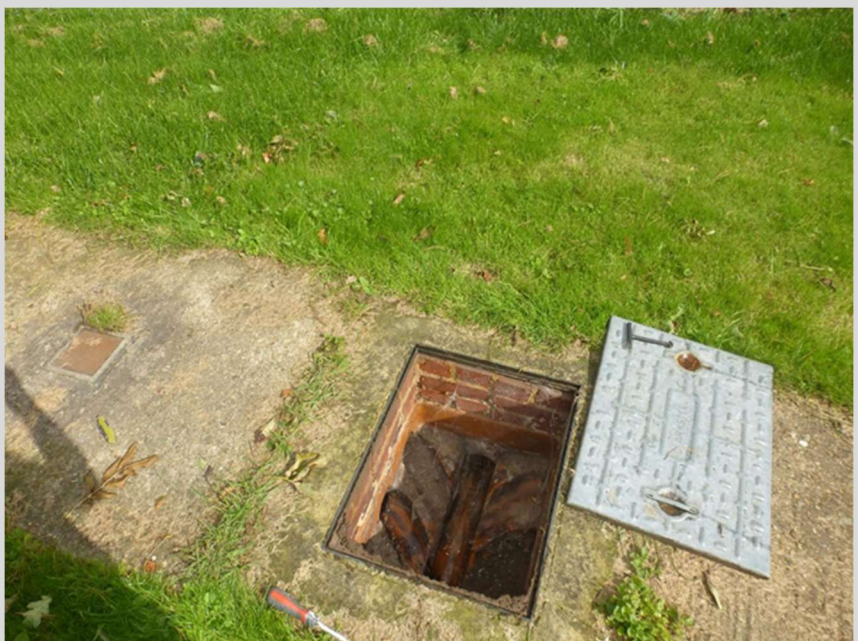
JPEG No: P1220054

- 32.1.1 A brick built inspection chamber is located within the concrete path to the left side of the building with a lightweight metal cover. The chamber appears in fair condition and is free from visible blockages. It is recommended that the inspection chamber cover is regularly lifted and checked to ensure there are no blockages. Although there are no blockages, it may be prudent to have a CCTV Drainage Survey undertaken to confirm the condition of the below ground drainage.

Inspection chamber is present within the concrete path to the left side of the building with a lightweight cover. Inspection chamber appeared free from significant defects and blockages. Hand missing to inspection chamber cover.

- 32.1.2 One of the handles is missing to the metal inspection chamber cover. Replacement is recommended so the cover can be easily lifted for future inspections.

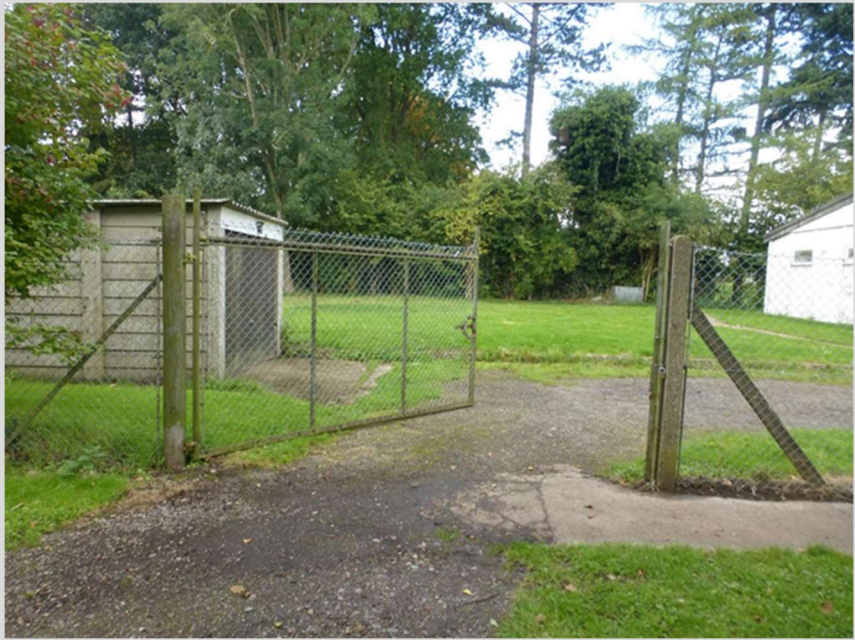
**PHOTO 34.1.2:**

- 34.1.1 Whilst we note the boundaries, these may not be the legal boundaries. Your Legal Advisor should make further enquiries on this matter and advise you of your potential liability with regard to any shared structures, boundary walls and fences.
- 34.1.2 The subject property and detached garage are enclosed by chain link fencing and a number of trees and bushes. Where visible, the concrete posts and chain link fencing generally appear in fair condition.

The property is enclosed with chain link fencing fixed to concrete posts, metal vehicular and pedestrian gate also located to front boundary.

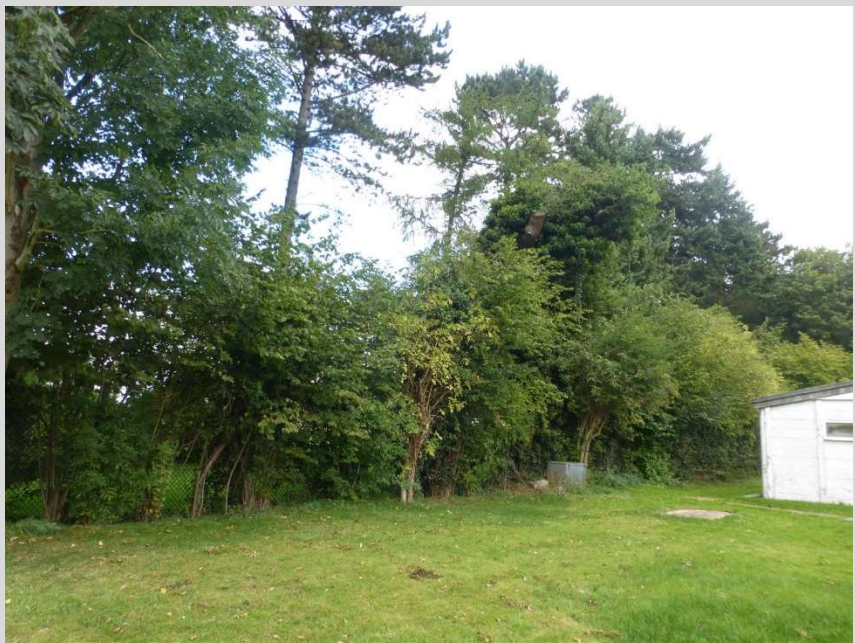
**PHOTO 34.1.2:**

Vegetation will require continual up-keep and pruning to rear boundary.

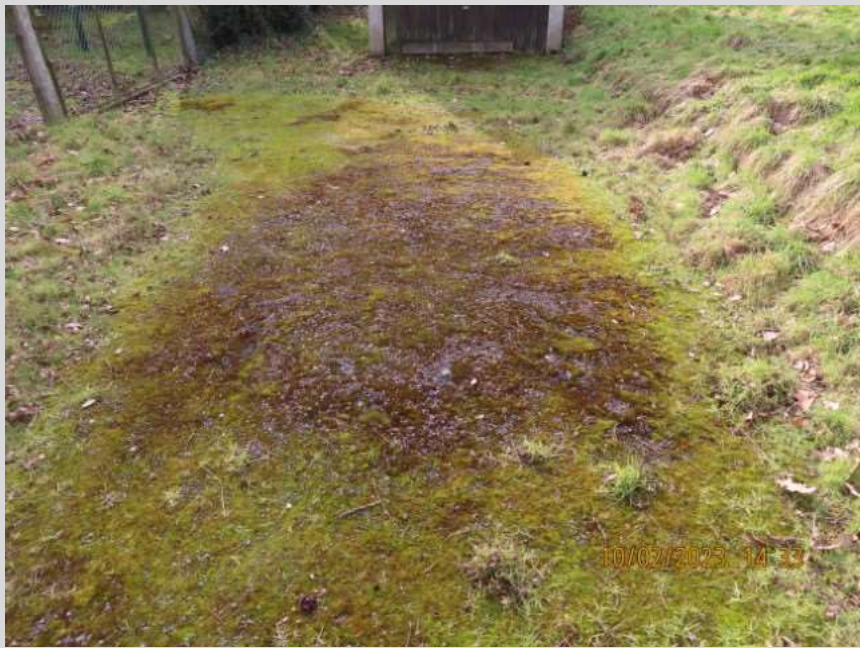
JPEG No: IMG\_9113

- 34.3.1 A concrete path is provided to the left and rear of the property. Moss growth was noted to the rear path which will require cleaning to prevent premature deterioration and damage to the concrete surfaces.

Extensive moss growth  
on path.

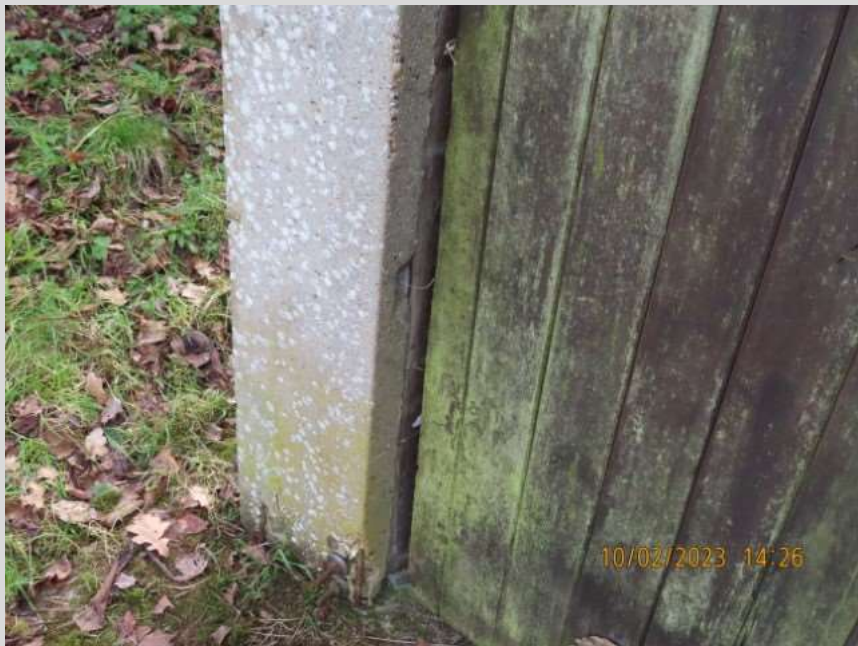
**PHOTO 34.5.1:**

34.5.1 A detached single garage is provided to the front left of the property adjacent to the vehicular entrance gate. The garage is formed with prefabricated concrete posts and panels, although the wall panelling to the rear section has been replaced with blockwork. Square openings with the wall panels have been infilled with timber panels.

Detached garage formed with concrete posts and panel system with asbestos cement roof and timber up and over garage door. Rear section of garage appears to have been replaced with blockwork.

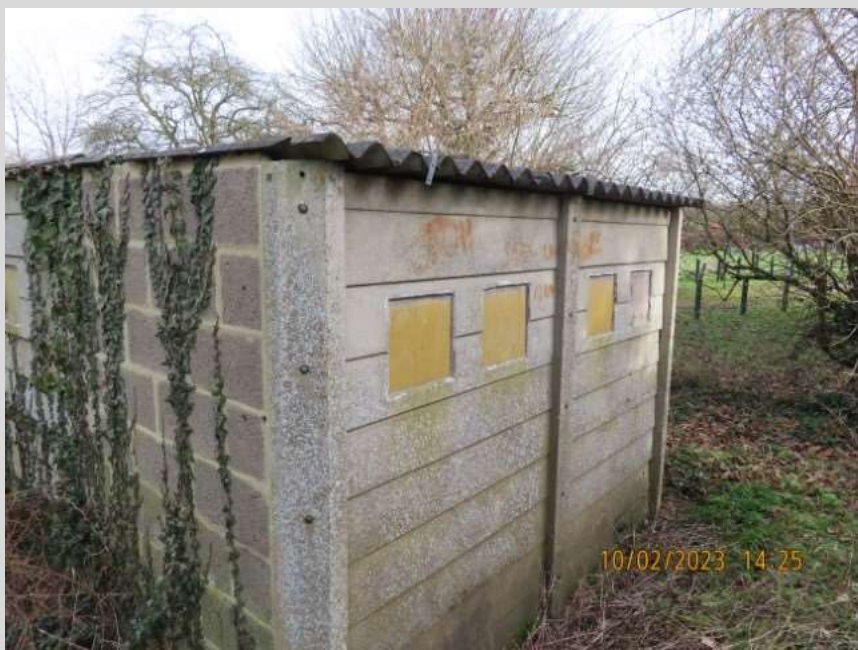
**PHOTO 34.5.1:**

Detached garage formed with concrete posts and panel system with asbestos cement roof and timber up and over garage door. Rear section of garage appears to have been replaced with blockwork.

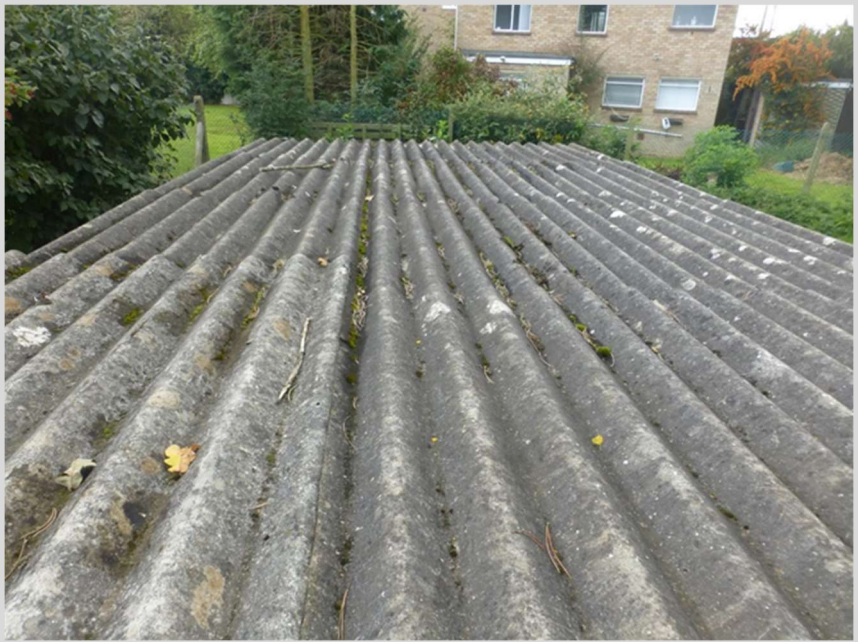
**PHOTO 34.5.2:**

- 34.5.2 The roof is formed with corrugated asbestos cement sheeting laid over metal joists. Daylight is visible between the wall and roof covering at the eaves where the sheeting is damaged which may allow water ingress from driving rain. Some of the bolt fixings to the roof sheets are also missing caps and are corroded. Damaged roof sheets and defective fixings should be replaced. Reference should be made to the Asbestos Survey prior to undertaking any remedial works to ensure works to any asbestos containing materials are undertaken safely and in accordance with current legislation.

Asbestos cement  
sheeting to garage roof.

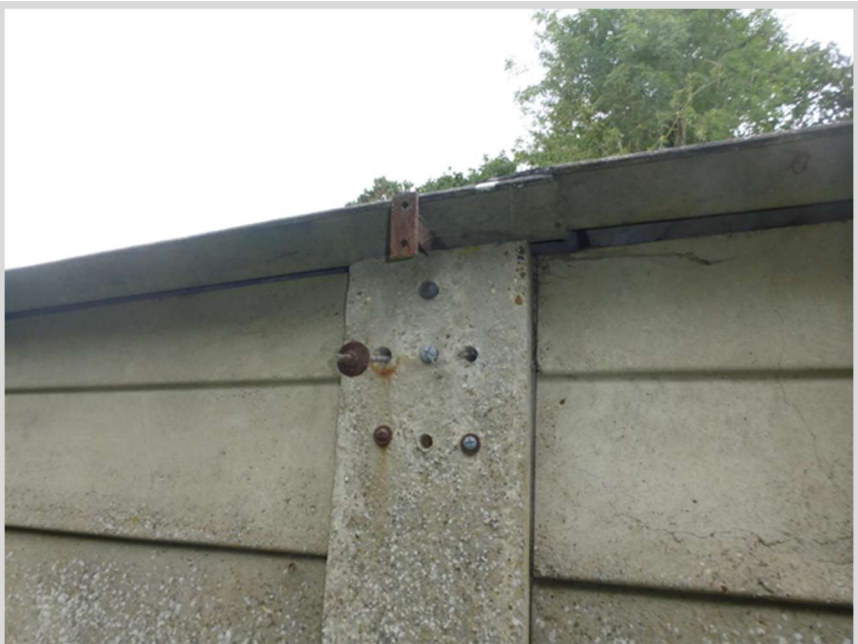
**PHOTO 34.5.3:**

- 34.5.3 The bolt fixings to the external post on the left side of the garage are displaced at high level and require re-fixing or replacement to prevent failure of the structure.

Bolt fixing to concrete  
post on left side  
displaced and corroded.

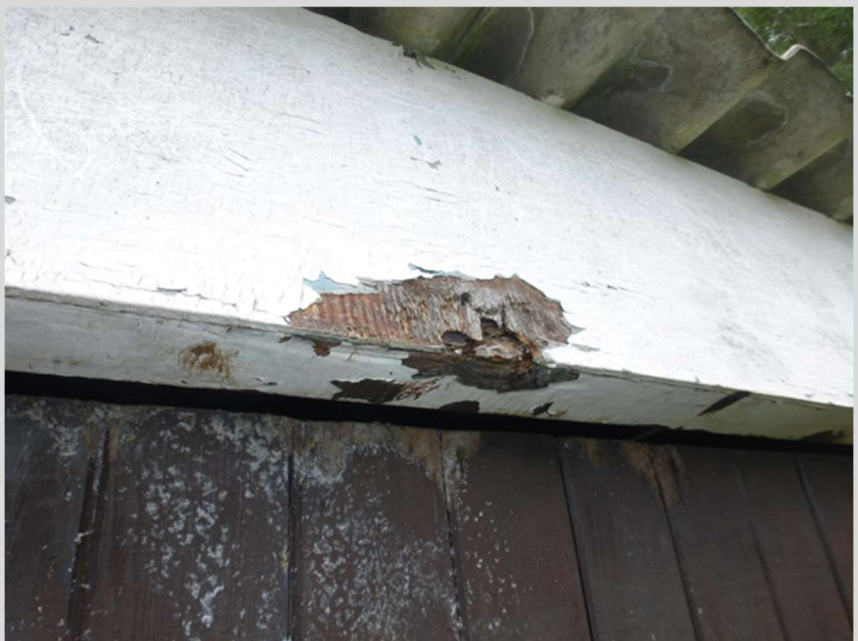
**PHOTO 34.5.4:**

- 34.5.4 A timber up and over door is provided to the garage which is dated and beginning to rot at the foot of the door. The fascia and soffit over the door is also damaged and beginning to decay. Replacement of the door, fascia and soffit are likely to be required in the near future.

Fascia and soffit  
damaged, above up and  
over door.

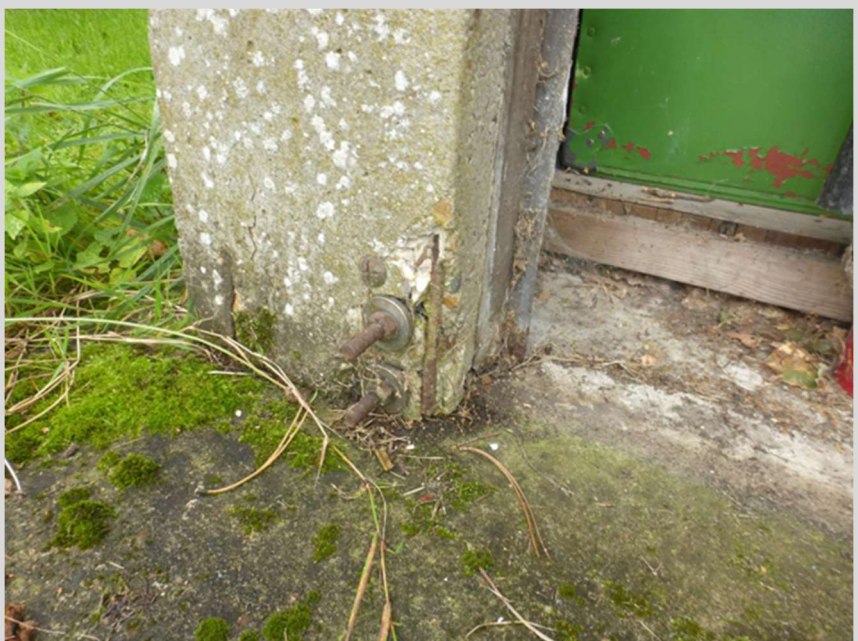
**PHOTO 34.5.5:**

- 34.5.5 The concrete post the left side of the garage door is damage with the metal reinforcement visible and corroded. Replacement of the post or repair to prevent further deterioration will be required.

Visible corroded  
reinforcement to  
concrete posts and  
concrete is spooling.

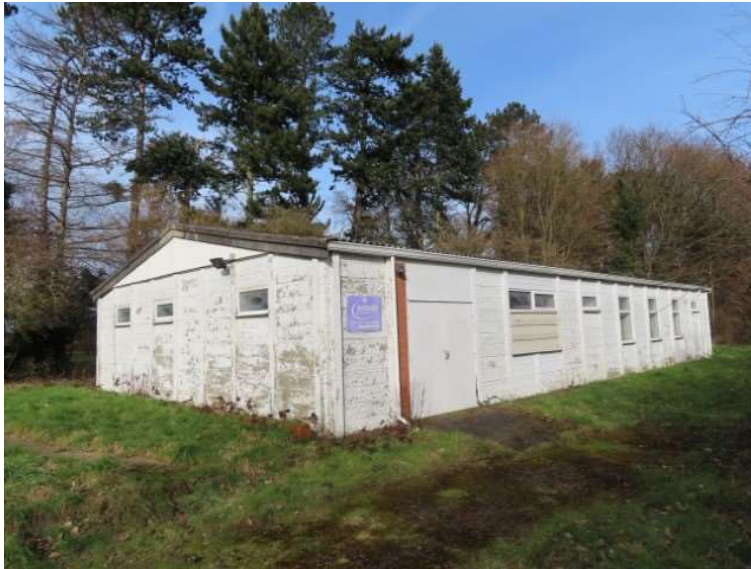
General view.

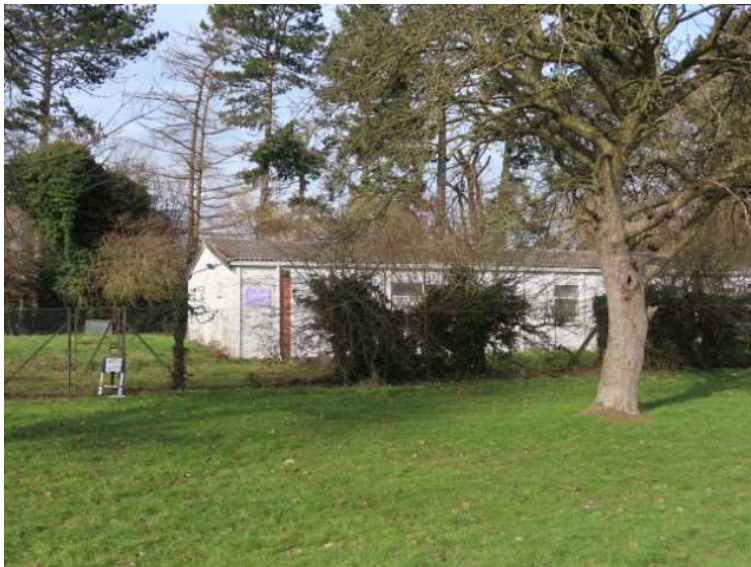
General view.

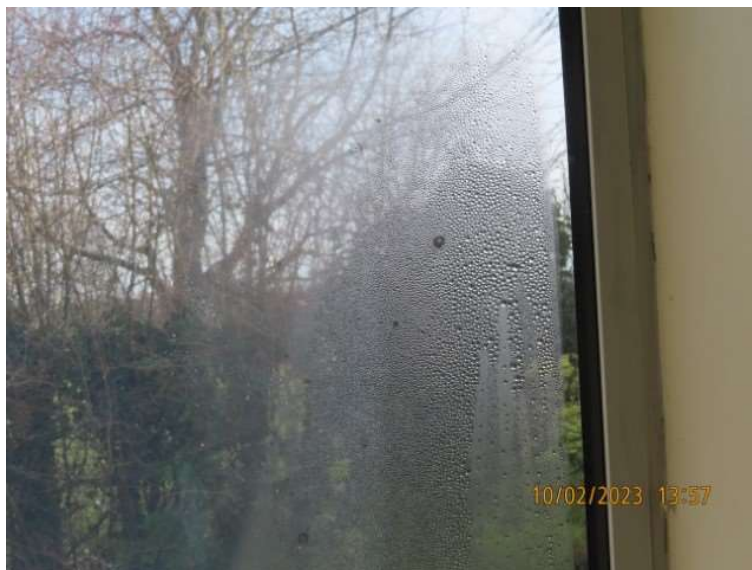
Interstitial condensation on perspex glazing.

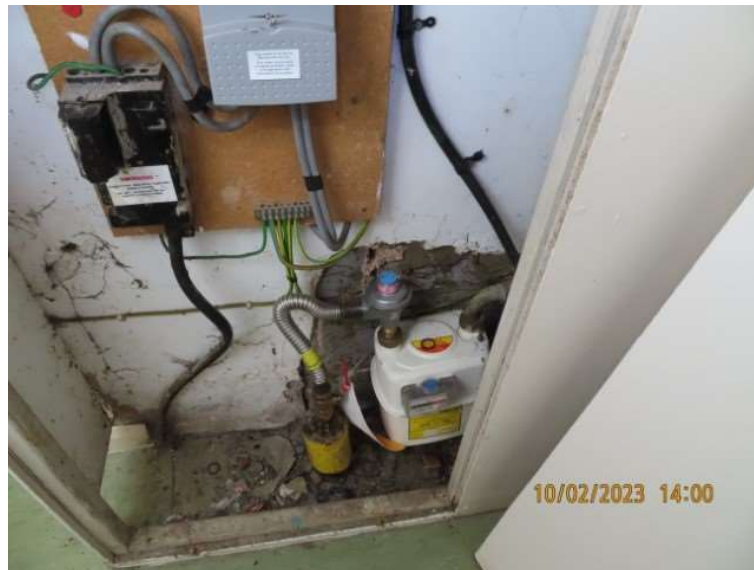
Electrical and gas intakes. Note: earth bonding appears to be acceptable.

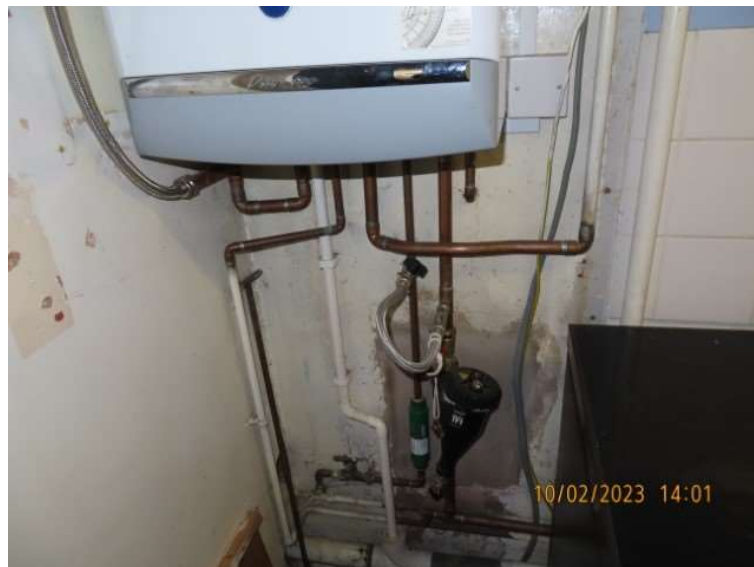
Flow and return pipework to combination boiler.

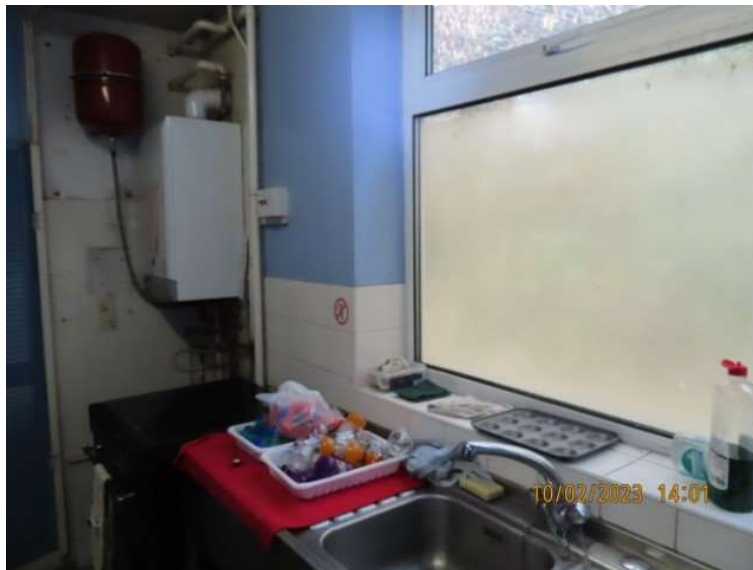
Kitchen finishes.

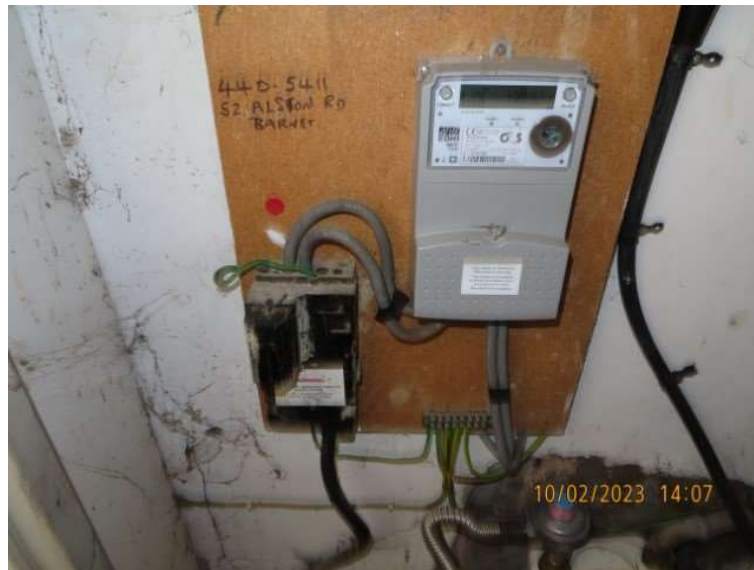
Electrical meter.

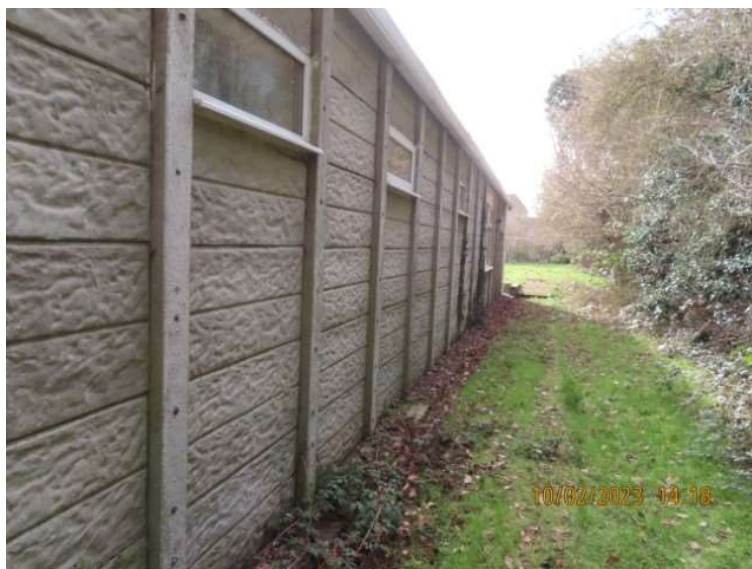
Rear elevation.
